Fluvial dynamics and selected methods of ecohydrological monitoring of restored Sviňovický brook channel

ZDENĚK KLIMENT¹, MILADA MATOUŠKOVÁ¹, MIROSLAV ŠOBR¹,
MARKĚTA POTŮČKOVÁ², JANA HUJSLOVÁ¹

¹ Charles University in Prague, Faculty of Science,
Department of Physical Geography and Geoecology

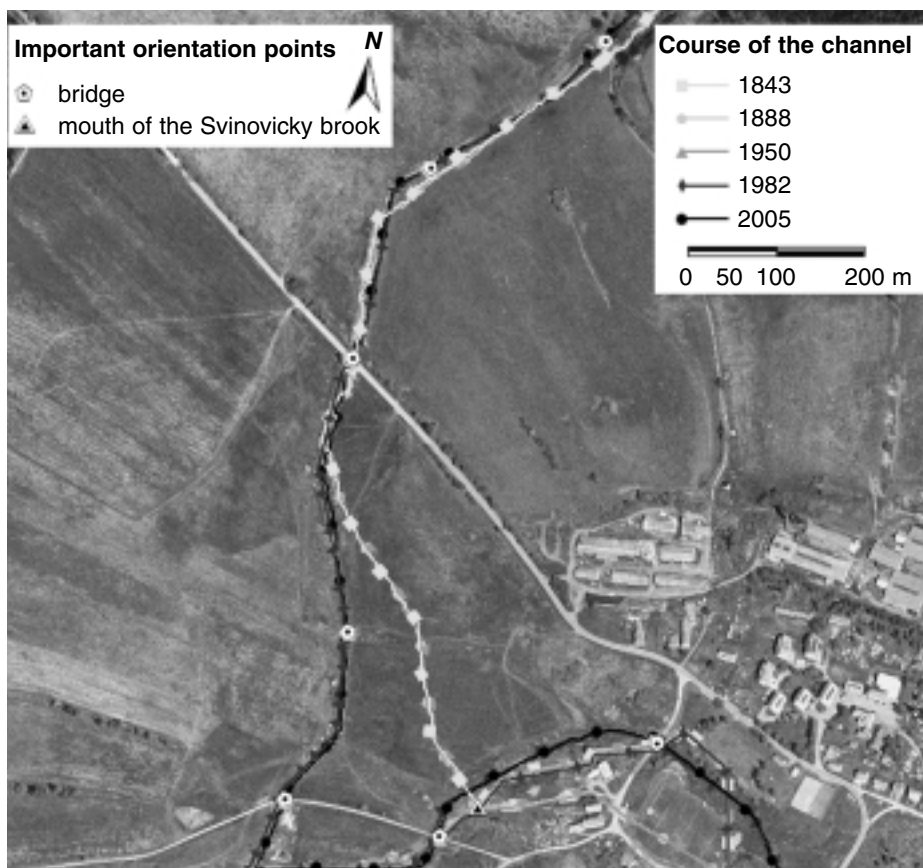
Figure 5: Historical changes in the course of the Sviňovický Brook and the reach of the Zbytinyký Brook between 1843 and 2005

1982, orthoimage of the upper part of Blanice from 2005 – COSMC source). After processing the map sources, the course of the Sviňovický Brook and part of the Zbytinský Brook were put into vectors in the five monitored years – 1843, 1888, 1950, 1982, 2005 (see Fig. 5). In 1843, the character of the channel of the Sviňovický Brook was natural with gentle bends. It ran south-west and, approximately 180 metres north of the road, it turned to the south. Approximately 100 metres from the road the channel's direction changed from the south to south-east. The Sviňovický Brook emptied into the Zbytinský Brook at the start of the village of Zbytiny. The course of the Sviňovický Brook channel in 1888 and in 1951 display only small differences. In the upper part of the brook above the road, the course is practically identical; in the lower part the bends have moved slightly. The Sviňovický Brook was very significantly affected by human activity during the time of agricultural collectivization during socialism in the 1970s and 1980s when amelioration improvement were carried out. It was straightened and a 1.132 km reach of the channel from the mouth to the Zbytinský Brook was reverted using concrete components into the uniform shape of a trapezoid cross-section profile with an incline of 1 : 1.5. In spring 2005, the above-mentioned partial restoration of the brook and adjacent reach of the Zbytinský Brook under the village of Zbytiny was carried out. The concrete fortification was removed, the channel bank incline was changed and the channel bed was equipped with stone rapids. Small bends were created on the short reach under the road bridge. The restored channel was left to develop spontaneously. The restoration was carried out in a different place than the original course before 1970.

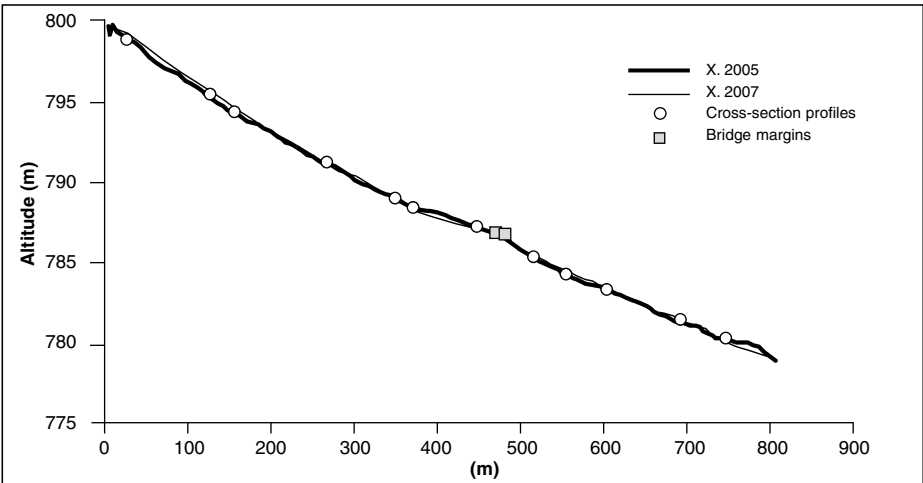
Figure 7: Changes in the longitudinal profile of the restored channel, 2005–2007

of the brook. The changes in the stream bed surface level are up to 40 cm (Fig. 6). While some bends were deepened, the accumulation parts of the profile were filled up, which resulted in the disappearance of other smaller bends. This, in fact, made the channel straight again. Regarding the dynamics of the longitudinal profile of the brook, the road bridge is beginning to be an obstacle to the flow. The last measurements in 2007 and in spring 2008 did not display any significant naturally caused changes in the channel, partly since there were neither significant rainfall-runoff events nor any larger discharge due to the melting of snow cover during this time. The channel is in the same condition as in spring 2006 with some exceptions such as the extension of eroded reaches, the receding of the channel edge (especially in the case of the cut banks), and certain stream bed accumulation and bank erosion at the start and end of the transport reaches (Fig. 7).

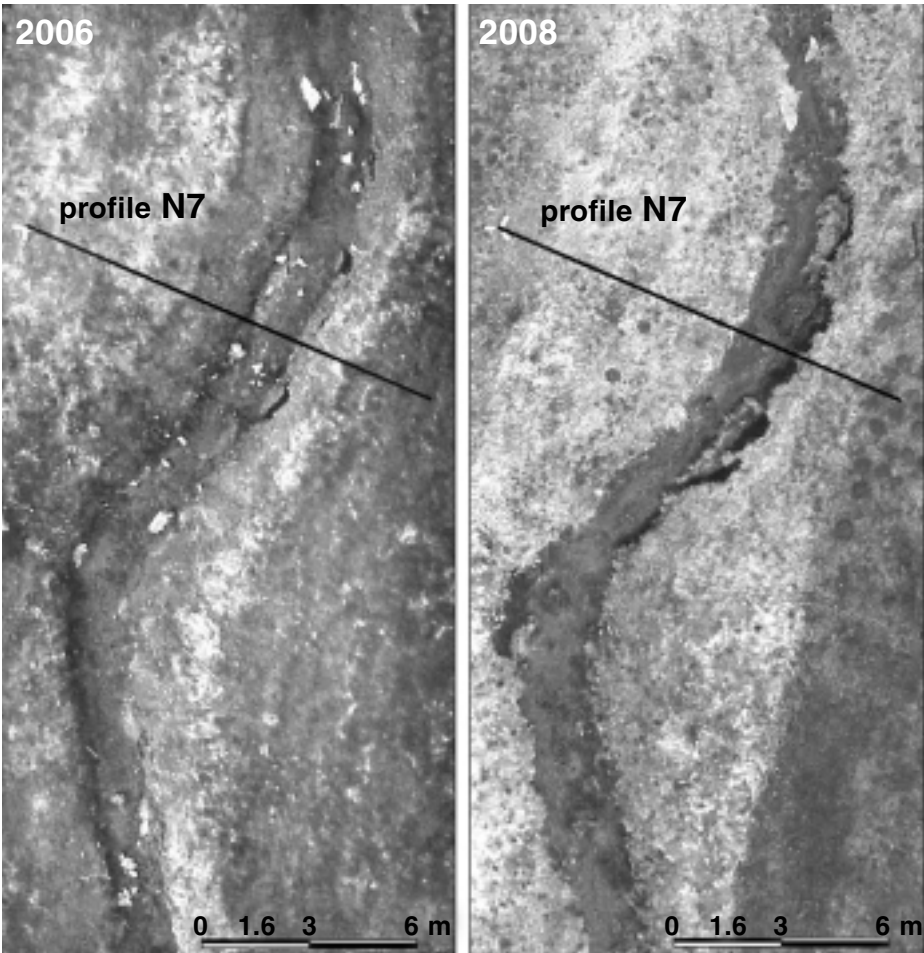
Figure 8: Examples of geo-referenced images taken by flying models in 2006 and 2008 (surrounding of the profile N7)

Fig. 8 and Fig. 9 can serve as examples of the processing and interpretation of the aerial images taken by the flying models in 2006 and 2008. These are images of the restored reach of the channel under the road bridge where, the caving banks were not filled with quarried stones at the end of 2007. The widening of the channel which occurred after the significant rainfall-runoff event in summer 2006, with bank erosion and subsequently falling of wash bank into the channel, is clearly visible in the pictures. Smaller boulders were taken further down the stream. The vegetation growth plays a considerable role in stabilizing the stream bed accumulation.

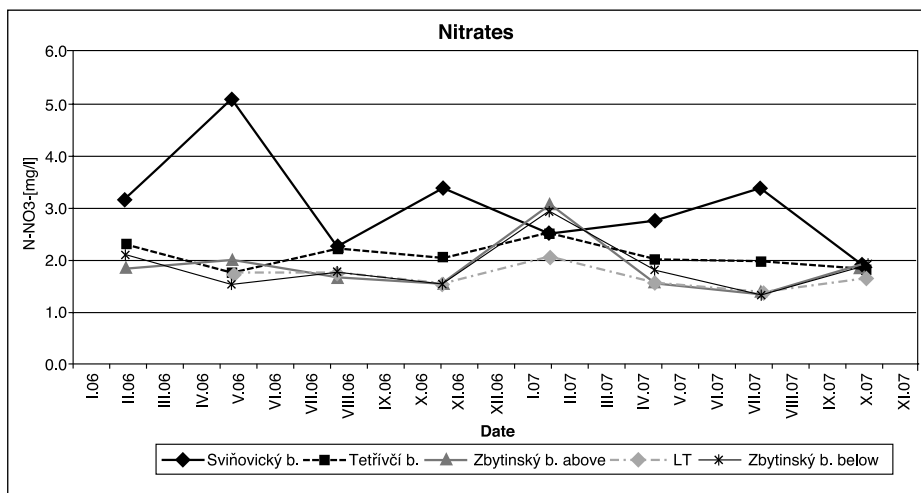
Regarding the parameters of conductivity and N–NO₃⁻, the restored reach of the Sviňovický Brook (the Sviňovický Brook profile) displays the highest burden. An increased concentration of chlorides was identified in this profile. The source of the pollution is probably the intensive cattle farming on the pastures in the immediate vicinity of the channel of the brook. The recorded concentration of N–NO₃⁻ falls into the 2nd quality class, i.e. only mild pollution – see Fig. 11. The results of the hydrochemical

Figure 11: Concentration of the N-NO₃⁻ parameter in the Zbytinský Brook catchment, 2006–2007 (analysis by the Environmental Laboratory, Faculty of Science, Charles University in Prague, K. Hryzáková)

analysis confirmed the existence of a significant point pollution source in the water basin of the Zbytinský Brook: the village of Zbytiny. Specifically, concentrations of COD, conductivity, N-NH₄⁺ and P-PO₄³⁻ are higher. The situation will undoubtedly improve after the sewage treatment plant Zbytiny comes into operation.
