Hazard mitigation of glacial lake outburst floods in the Cordillera Blanca (Peru): the effectiveness of remedial works

A. Emmer^{1,2}, V. Vilímek¹ and M.L. Zapata³

DOI: 10.1111/jfr3.12241

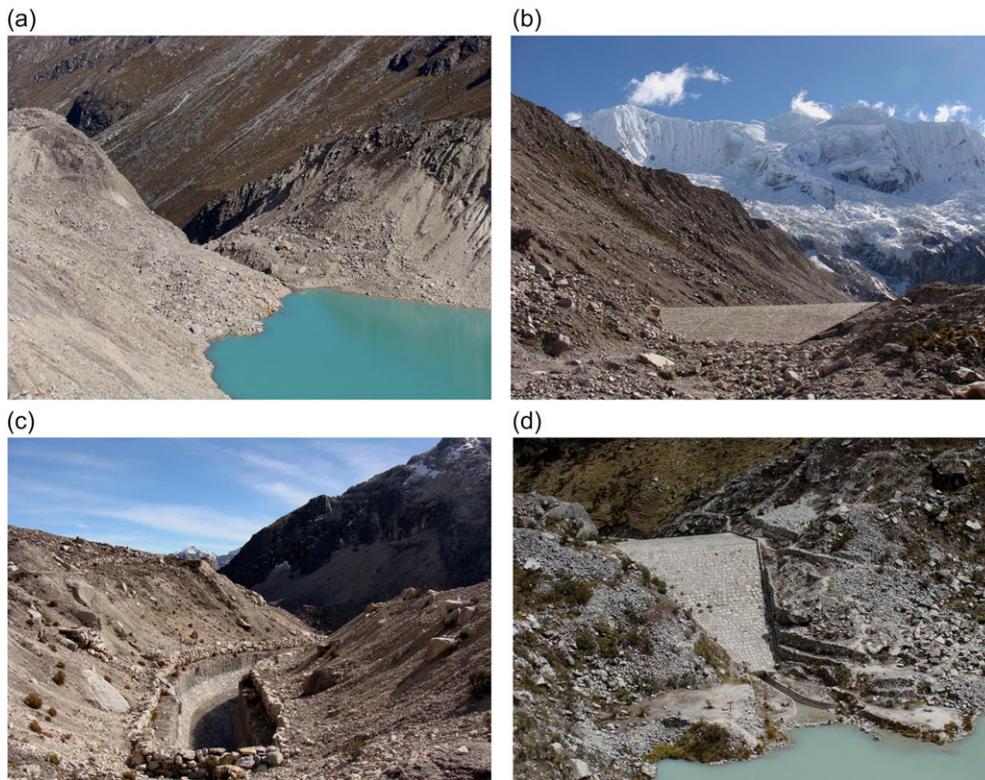
Open cuts are implemented by cutting through the moraine dam to lower and/or fix the lake level (and thereby the volume of retained water). Another goal is to prevent a surface outlet due to erosion following a sudden increase in flow rate (e.g. after an icefall into the lake) by cementation and concreting. Open cuts are mostly combined with artificial dams in the Cordillera Blanca (see below), but there are cases where they are implemented independently (e.g. Lake Arhueycocha in the right tributary of the Santa Cruz Valley, Lake Cochca above Lake No. 513 in the Hualcán Valley, or Lake Milluacocha in the Ishinca Valley; see Figure 2(a)).

Artificial dams (Figure 2(b)) are built especially to increase dam freeboard (and thereby the retention potential of the lake) and to prevent a lake outlet due to the direct impact of a displacement wave(s) and unexpected increase(s) in water levels. Artificial dams are usually built from concrete or stone walls with earthen fill, and they are often more than 10 m high. They are implemented solely in moraine-dammed lakes in the Cordillera Blanca and mostly in combination with open cuts (see above), above the lake outlet or in other locations where the dam freeboard needs to be increased (usually a naturally lowered point on the moraine crest; see Figure 2(c), (d)).

Figure 2 Example of open cuts and artificial dams. (a) A failed moraine dam of Lake Milluacocha equipped in 2000 with an open cut; (b) a separate artificial dam increasing the dam freeboard of Lake Palcacocha in the naturally lowered part of the dam crest (not the lake outflow); (c) a downstream view of the open cut of Lake Ishinca from an artificial dam providing a freeboard of 5 m; and part (d) an artificial dam providing a freeboard of 12 m and an inlet to the open cut draining Lake Llaca.

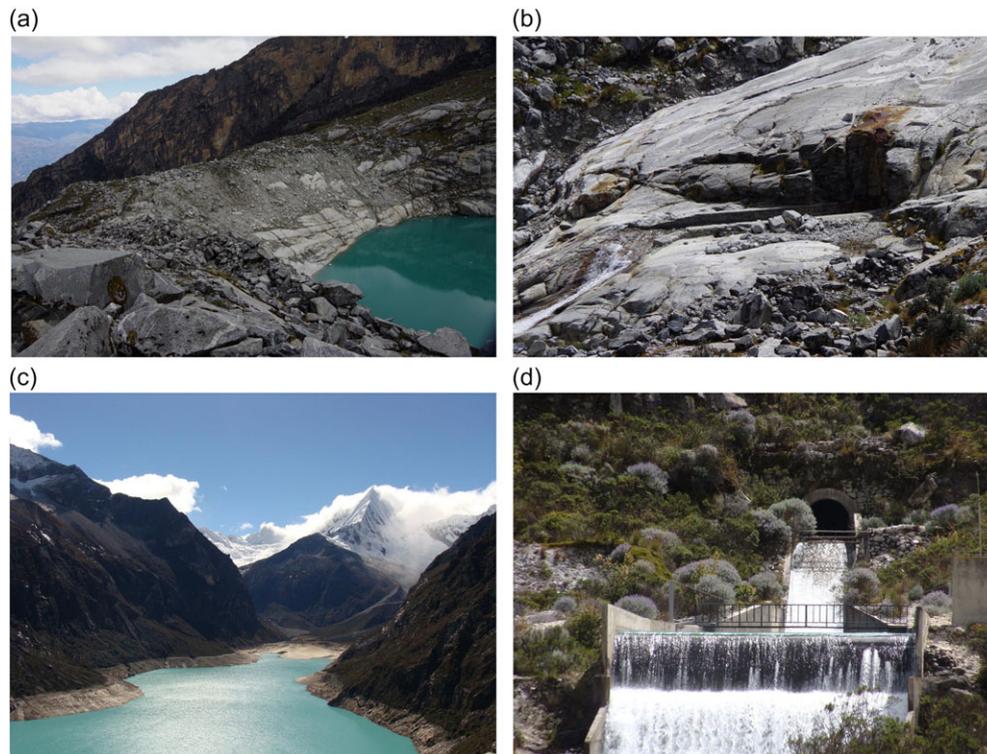
Figure 3 Examples of lakes equipped with tunnels. (a) A bedrock dam of Lake No. 513 partly covered by moraine material, and the debris-free bedrock indicates the original water level before being lowered 20 m; (b) the outlet of a tunnel dug through the bedrock dam of Lake No. 513; (c) an overview of Lake Parón from the Jatunraju glacier damming the lake (note the light belt around the lake indicating a decrease in the water level of about 40 m); and (d) the outlet of the tunnel below Lake Parón.

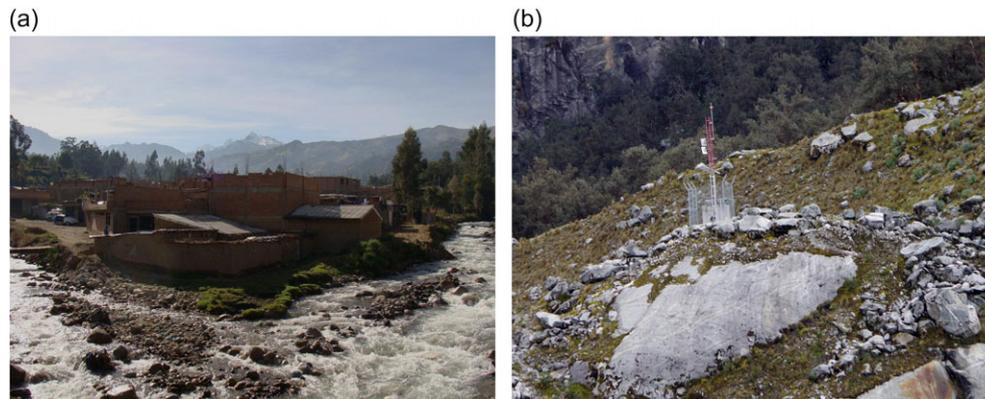
Figure 4 GLOF vulnerability issue in the Cordillera Blanca, Peru. (a) Inappropriately located buildings on the confluence of the Quilcay River and Cojup Stream, Nueva Florida, Huaráz, Peru; (b) shows a transmission tower of the early warning system installed in the Chuchun Valley to warn the inhabitants of Carhuaz of a glacial lake outburst flood (GLOF) from Lake No. 513.
