## Using dendrogeomorphology in research on a slope deformation in Běleč, Czech-Moravian Highland (Czech Republic)

Research on the Běleč creeping slope deformation is a contribution to identification of the causes of a breakdown of the water-supply conduit of the Brno regional water-supply network and to ensuring its regular operation.

**Key words:** Deep-seated slope deformation, breakdown of the water-supply conduit, dendrogeomorphology, Czech-Moravian Highland

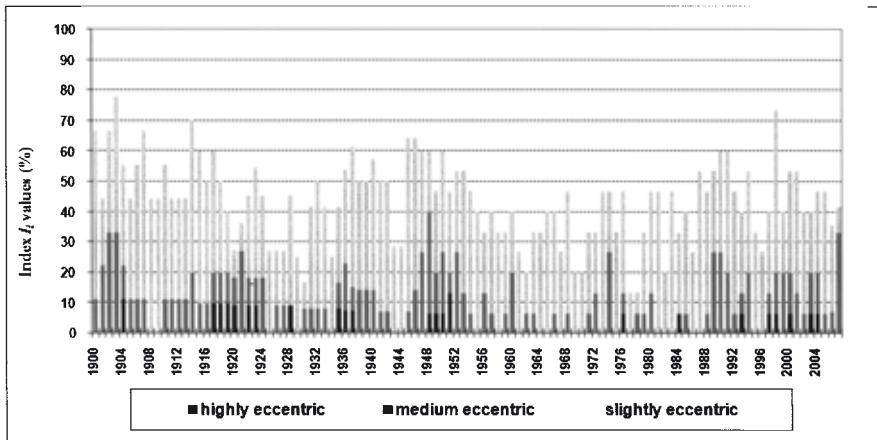
Fig. 5  $I_i$  values according to the degree of tree ring eccentricity for the whole analysed area

Fig. 5 shows that index  $I_i$  does not reach higher levels, i.e. movements do not occur in all portions of the slope at the same time. Therefore the level of eccentricity was assessed separately for trees growing within the delimitation of the slope failure from geomorphological mapping.

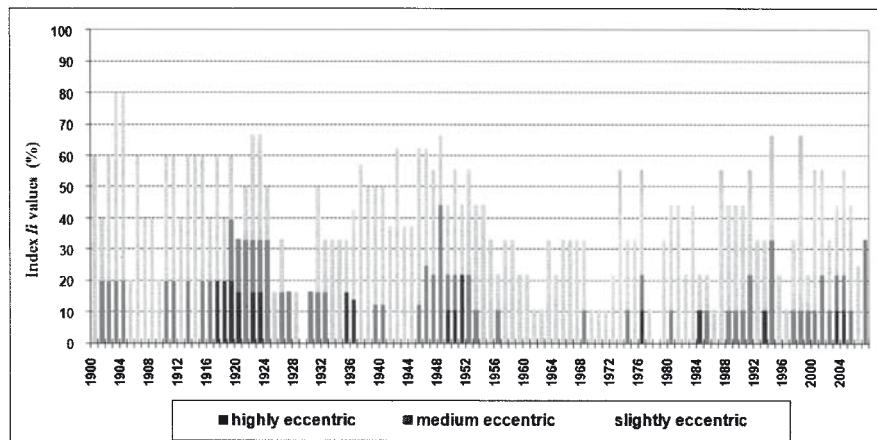
Fig. 6  $I_i$  values according to the degree of tree ring eccentricity for the presumed delimitation of the slope deformation

Fig. 6 shows that within the slope deformation, movements in its whole profile cannot be presumed. They are rather movements differentiated into partial portions of the slope. Nevertheless, according to the calculated values several periods of increased movement activity can be determined, i.e. in the years 1915, 1944, 1947, 1975, 1987, 1993, 1997 and 2002.

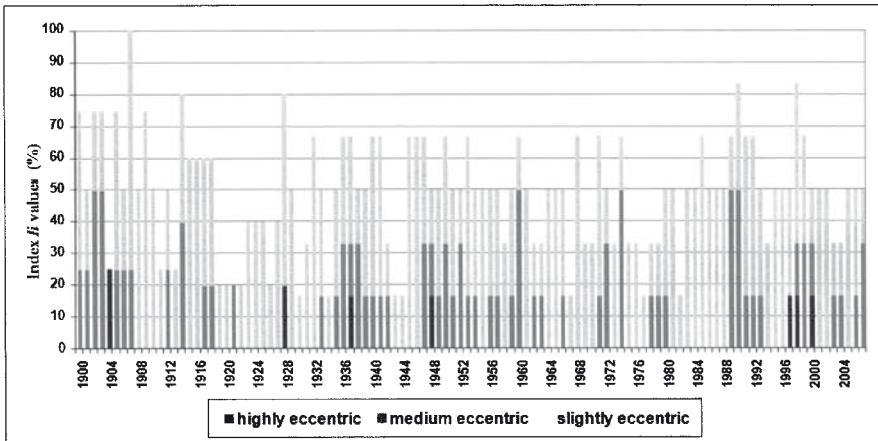
Fig. 7  $I_i$  values according to the degree of tree ring eccentricity of trees situated on the slope in the neighbourhood of the slope deformation

The graph in Fig. 7 does not display significant maxima; the levels are, differently from those for the trees directly on the failure, distributed relatively evenly for the whole studied period. Periods of a slightly increased formation of eccentric tree rings evoke events in the years 1935, 1947, 1959, 1973, 1988 and 1997. These periods (with the exception of the years 1947 and 1997) do not correspond to similarly delimited periods within the slope failure. It can thus be presumed that the portion of the slope further to the SW is not included in the slope deformation area of interest. Nevertheless, in order to compare the eccentricity level for individual trees in this area, the slope is affected at least by movements of shear character affecting probably only slope accumulations. This is proved by an increased degree of eccentricity in the periods 1936–1941 and 1948–1950 manifested accordingly in trees 14, 16, 18 and 20. In compliance with relief morphology and localization of these trees, it is possible that in the given years movements got quicker and a smaller slope movement of stream character developed there.

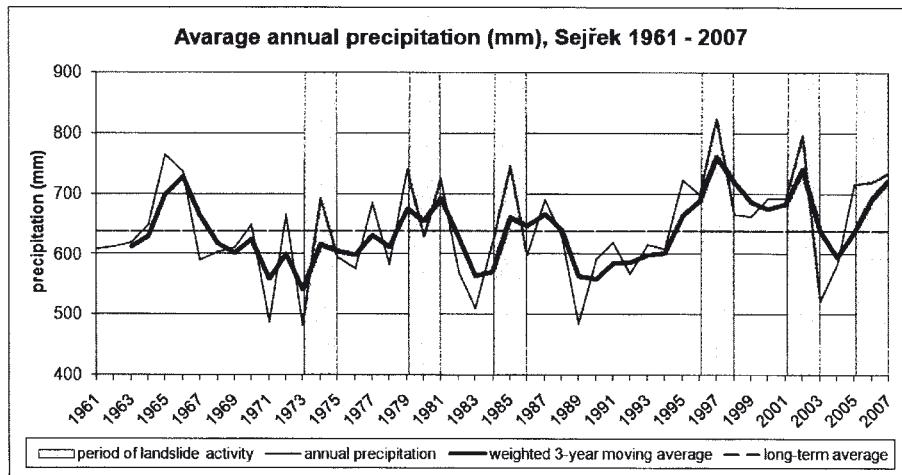
Fig. 8 Comparison of periods of increased slope deformation with rainfall data

The influence of precipitation on the activity of slope deformation was assessed by a weighted 3-years moving average of annual precipitation. Figure 8 shows a significant

increase of slope deformation in 1997, 2002 and 2006, when an above-average precipitation amount was registered. Nevertheless, there is no significant correlation between moving average and data from tree-ring analysis indicating movements in 1974. There is correlation rather between obtained data and total annual precipitation. This indicates a rather shallow flow movement rather than deep-seated movements. Unfortunately, quantifying of the deformation rate was impossible from the dendrogeomorphological analysis, so that an exact comparison of deformation activity with the rainfall data was not assessed. Nevertheless, peaks on the curve agree with periods of increased slope movement activity (Fig. 8). However, there is better correspondence for values of total annual precipitation than for moving averages.

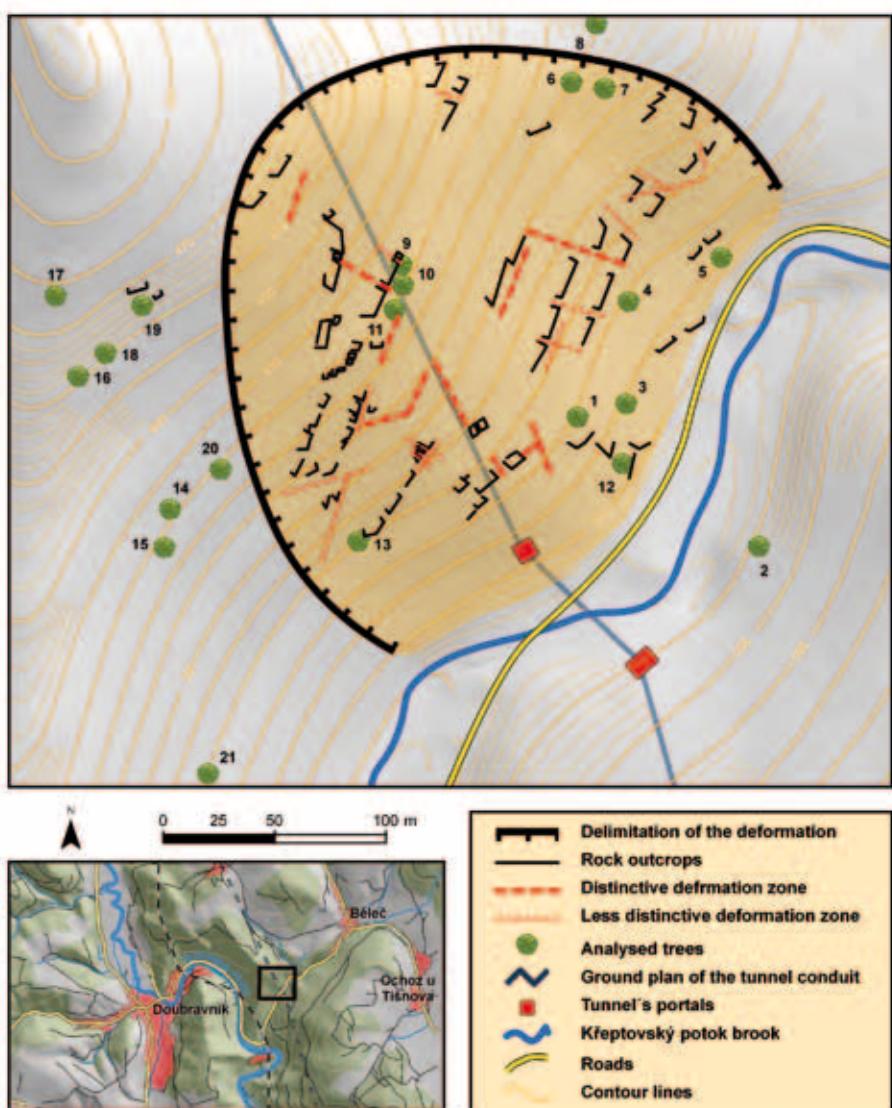
Fig. 2-2 The area of the Běleč slope deformation with localization of analysed trees

On the basis of field research, surface forms (see Fig. 2-2, colour appendix) on the slope above the Běleč I portal bearing evidence of the presence of a slope failure were described.

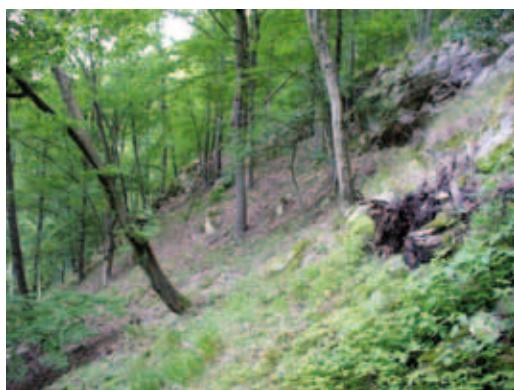
The main line of terrain steps bordered by depressions forms characteristic structures of several sliding couloirs. The morphologically most pronounced are the smallest and at the same time the lowest ones of them (Fig. 3-2, see colour appendix). Higher situated steps are then part of a significantly greater couloir reaching probably to the area of a further partial ridge situated westwards. The couloir's base is concave in crosscut with less pronounced outcrops.

Fig. 3-2 Landslide cirque in the lower portion of the slope

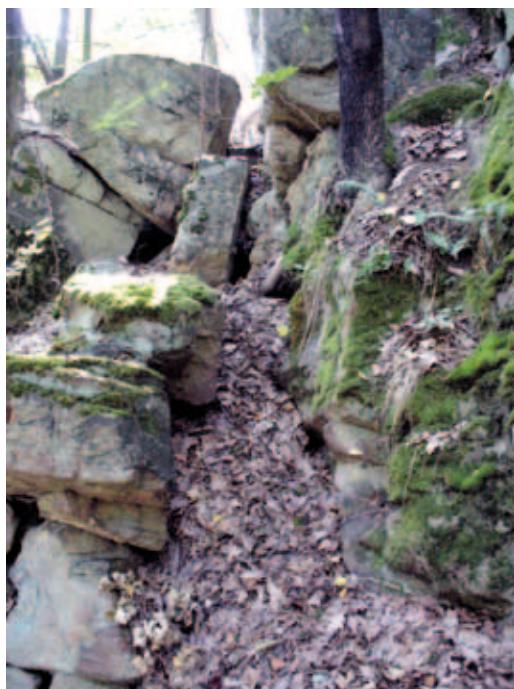
Other forms related to slope movements are linearly ordered forms of slope surface deformation oriented slantly to perpendicularly to the directions of the rocky outcrops walls (Fig. 4-2, see colour appendix). In places of intersection of these lines with outcrops there are rocks deformed by movements. Outside of the outcrops, the lines appear as zones of loosening of block debris or as steps or depressions in bloc fields. These lines are however interpreted as deformations of lower orders. In addition, cross zones of secondary deformation in NNE-SSW direction correspond in two places by their position on the slope surface to two main places of damaging of the tunnel. Also, two very pronounced failures crossing the slope in the direction corresponding to that of the water tunnel, but not to the structural one, are interesting.

Fig. 4-2 Linear deformation running across a rock outcrop
