**HydroEco'2015**

# The effect of soil erosion on ecosystem services

Ádám Kertész – Adrienn Tóth – Melinda Pálinkás

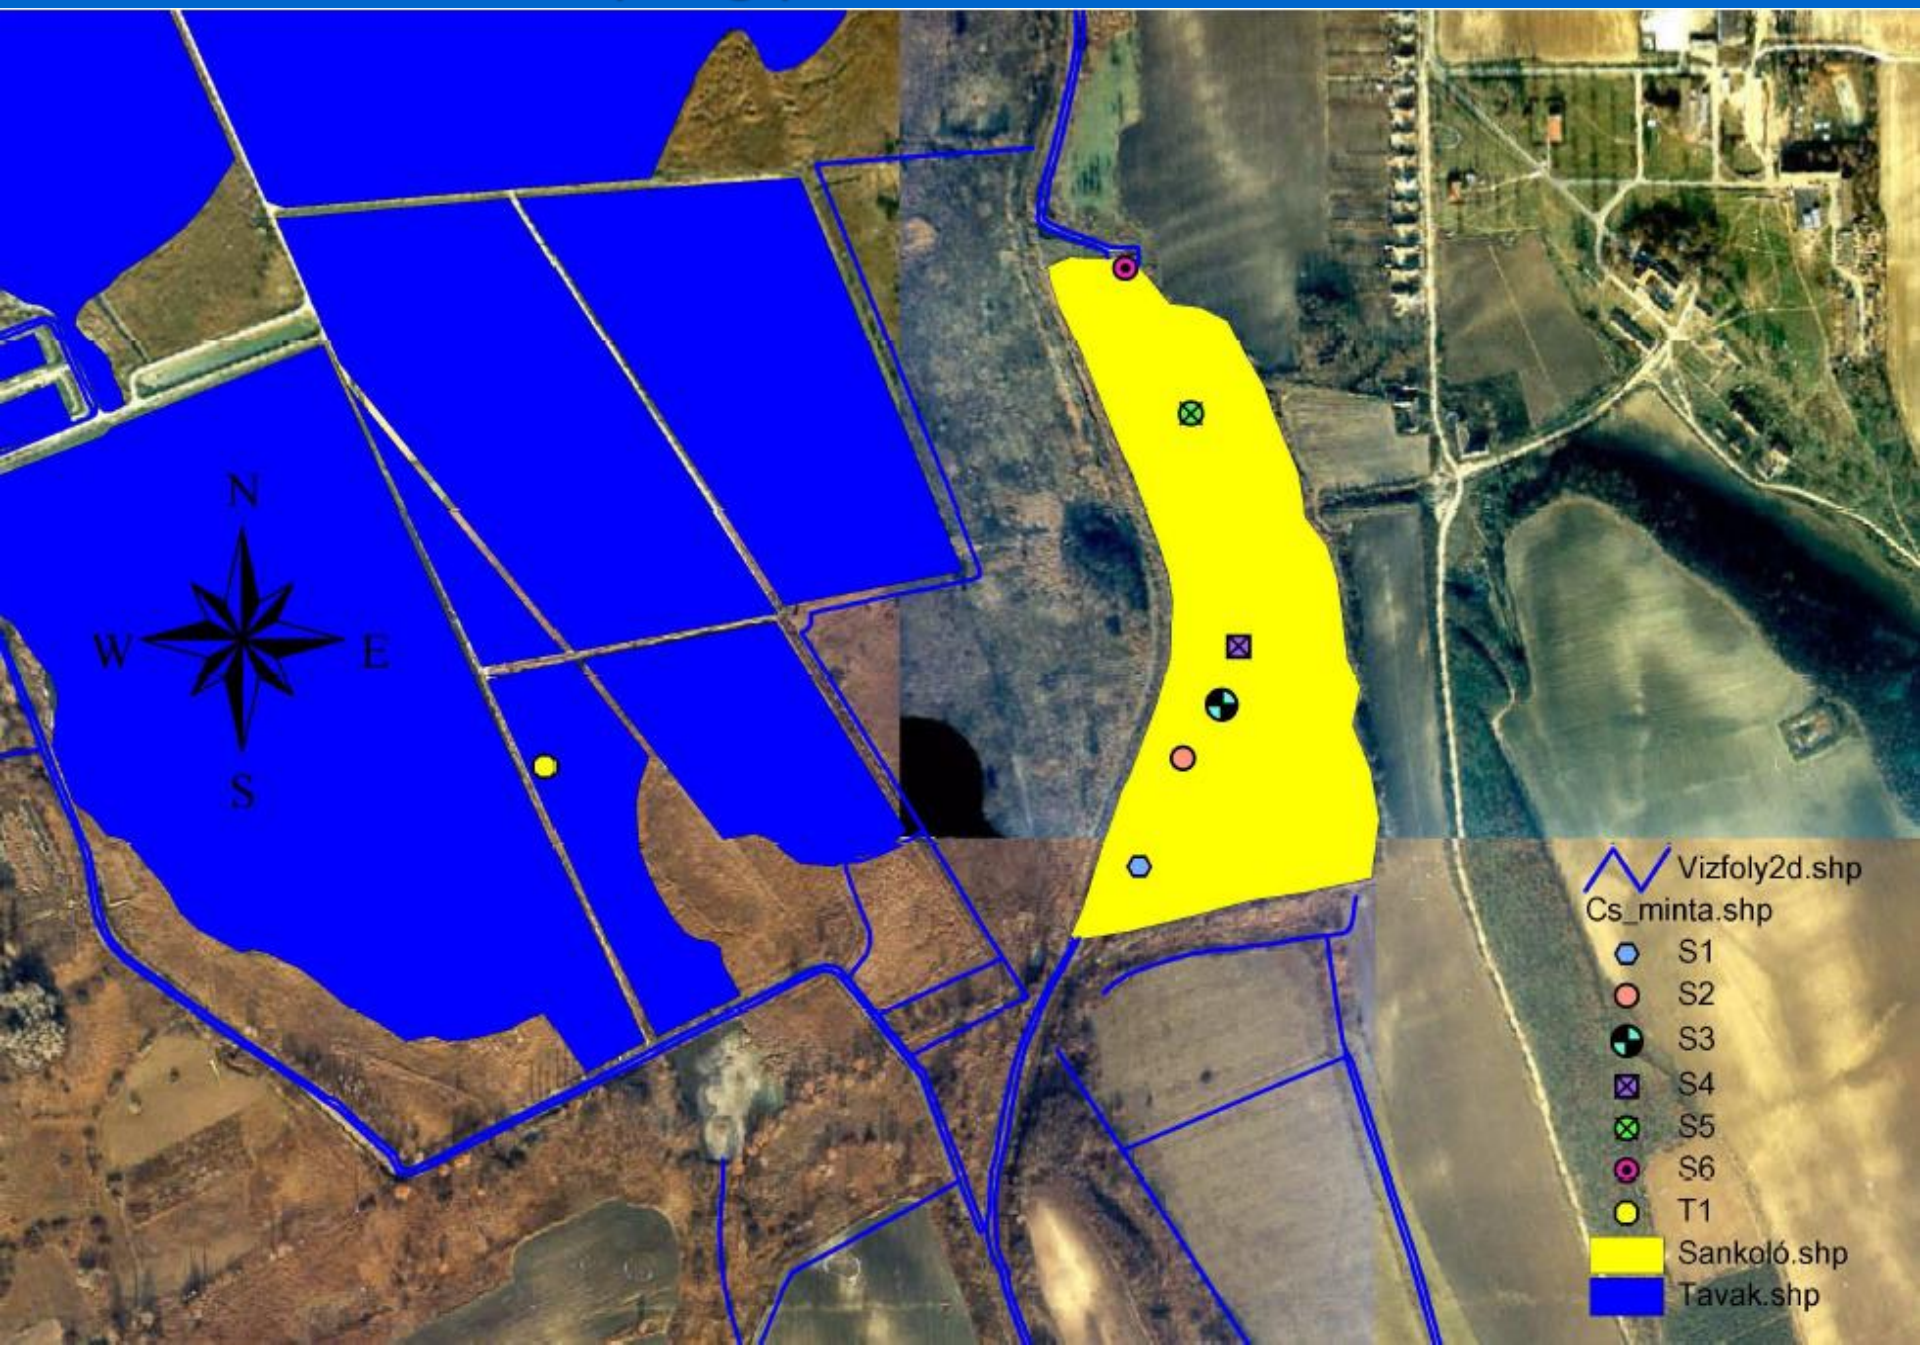
# Sampling points in the reservoir

- If there is no activity concentration at the top of the soil profile, the profile is eroded. The presence of Cs-137 activity in deeper horizons refers to deposition of topsoil on the top of the original profile
- The volume of the fallout was determined by applying reference profiles
- Reservoir and fishpond sampled
- Gully Erosion Activity (1968, 1984, and 2004) studied by using maps, air photos and field survey (Jakab et al. 2006)

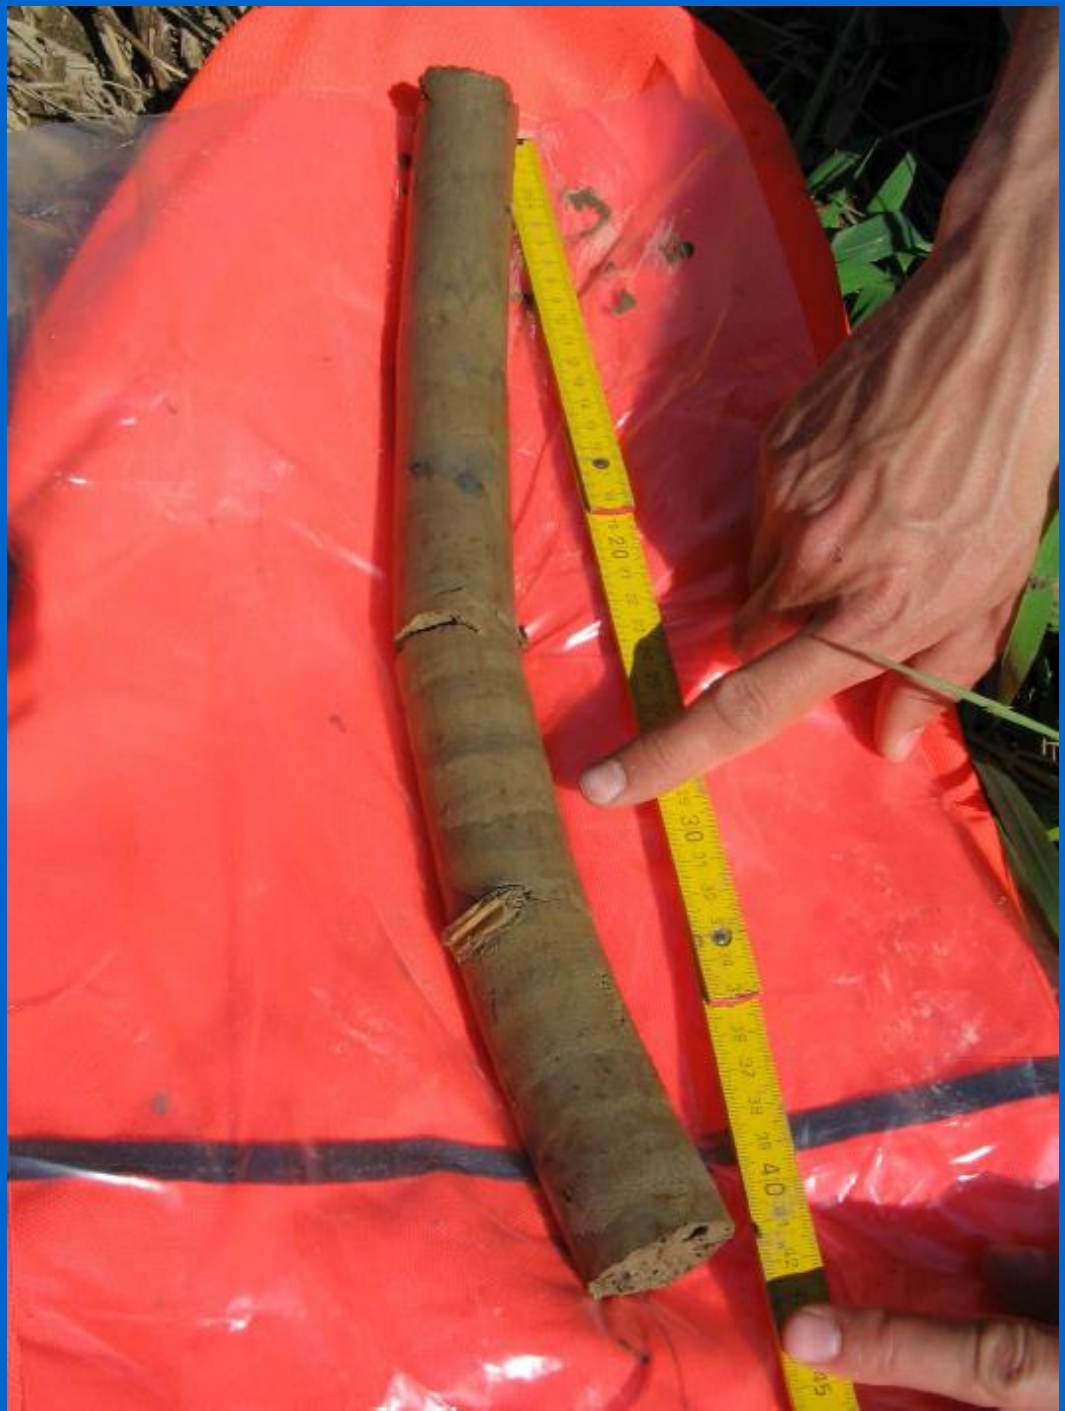
**A sediment sample  
from S2 point**

- The total activity value of the 130 cm is 6.5 times higher than that of the fallout ( $51\,350\text{ Bq m}^{-2}$ ). Smaller volumes mean that the sediment contains subsoil without Cs-137 activity, as a consequence of gully erosion
- Minimum 50% of the sediment comes from layers below 20 cm of the soil profiles of the catchment, eroded by gully erosion
- Former investigations:  $1\,198\,268\text{ m}^3$  material was moved in the catchment by gully erosion
