Slope deformations in eastern Moravia, Vsetín District (Outer Western Carpathians)

KIRCHNER KAREL¹, KREJČÍ OLDŘICH², MÁČKA ZDENĚK¹, BÍL MICHAL²

Key words: slope deformations, Western Carpathians

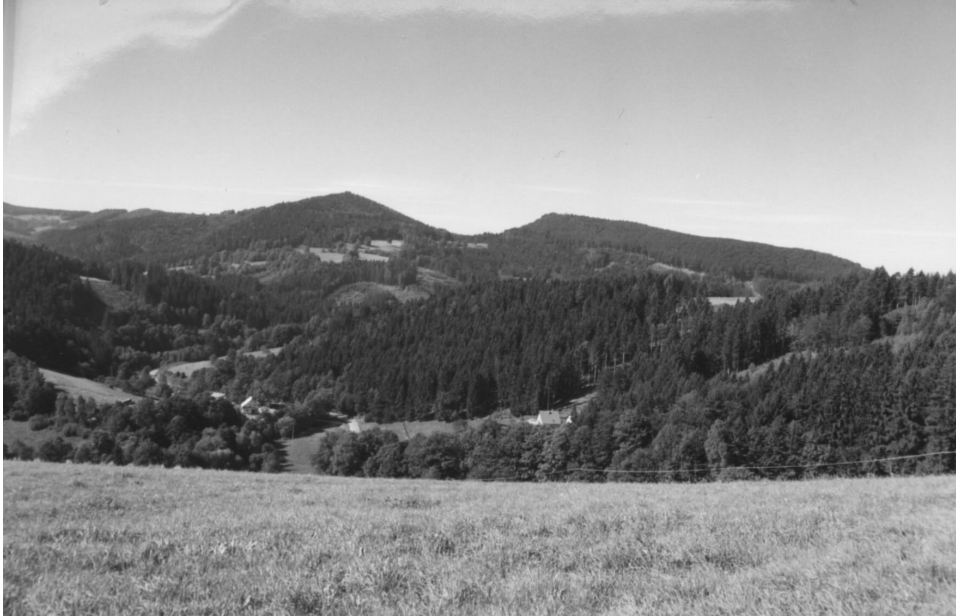
Photo 1: Western part of the Vsetínské vrchy Hills – typical flysch mountain relief with erosion-structural forms and slope deformations (surroundings of the Bystříčka village). (Photo Karel Kirchner)

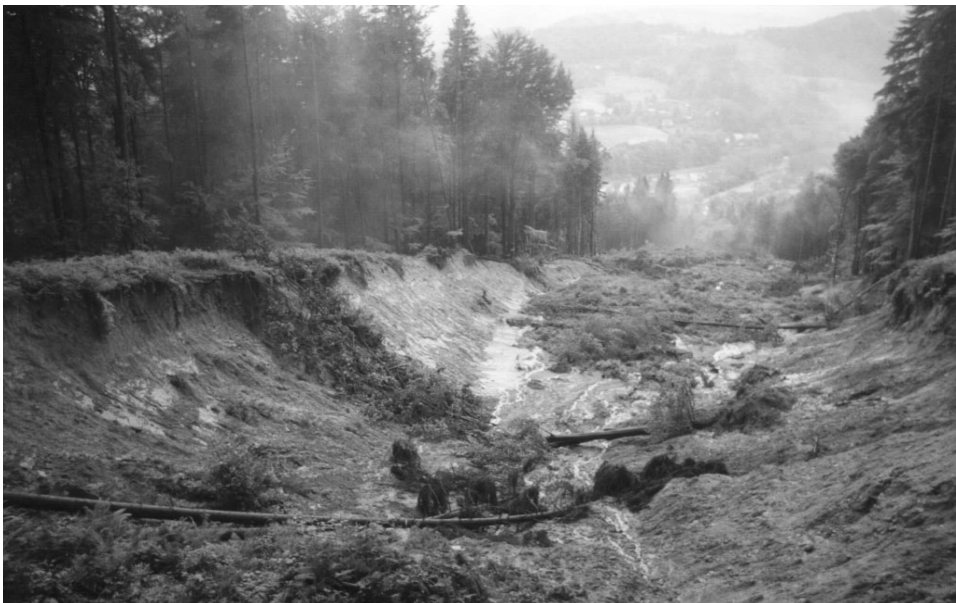
Photo 2: The landslide locality of Bystříčka – upper scar of landslide is structurally determined – a syncline. (Photo Oldřich Krejčí)

In the landslide locality of Bystřička (5 km to S from Valašské Meziříčí town, right valley slope of the Vsetínská Bečva river), two large landslides broke the railway between the towns of Valašské Meziříčí and Vsetín near the village of Bystřička on Monday, 7 July (Rybář et al. 1998). The accumulation front of one of them directly hit the railway track embankment, damaged rails, with the electrical mains trolley wires being taken down by falling trees. This landslide was structurally geologically controlled (a movement of the syncline core of the Rusava Member, Rača Unit). The lower parts of both landslides experienced severe water oversaturation of accumulated materials and the origination of earth and mud flows with a small runoffless depression. The movement of these flows down the steep slope heavily damaged the forest stand and raised a chaotic tangle of broken spruce trees in the accumulation part, thus forming an impervious barrier.

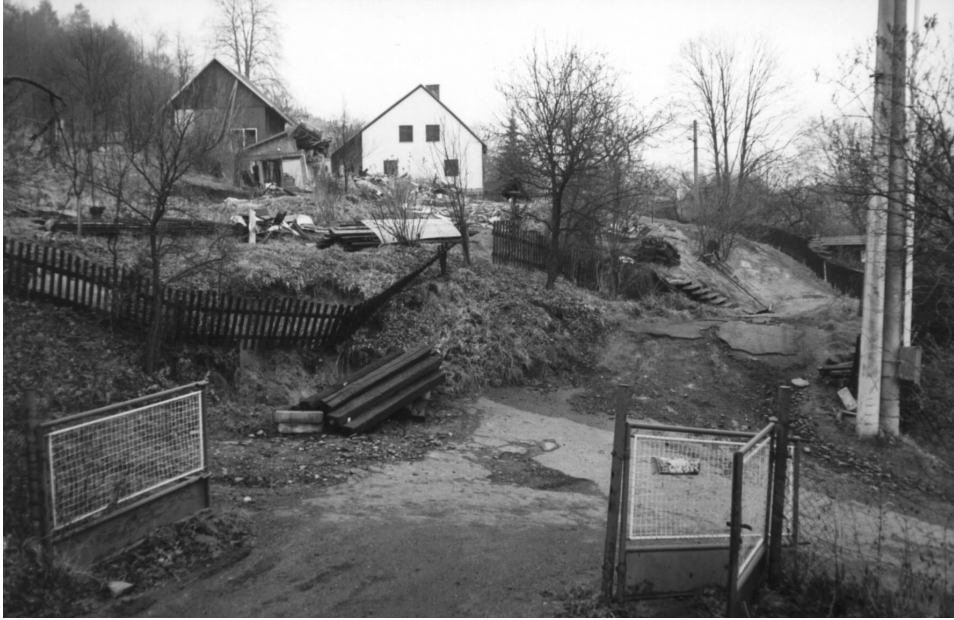
Photo 3: Central part of large landslide with damaged buildings in the Růždka village. (Photo Karel Kirchner)

The landslide in the Růžďka village (7 km to N from Vsetín town, valley of Růždecký potok brook – right tributary of the Vsetínská Bečva river) in an area occurred on the left valley slope in the village of Růžďka and was to 800 m in length with its width ranging between 100–200 m. The landslide damaged five houses, local roads, gardens and the adjacent forest stand (Photo 3). This landslide, still active and very deeply founded, was the most destructive in the whole Czech Republic in 1997. In it, a 20 m thick layer of sandstones of the Beloveža Formation (Rača Unit) forced out the underlying bedrock claystones. The accumulation part of the landslide reaches a thickness of up to 30 m. The landslide front is situated right in the housing zone and its extremely destructive effect results from the structurally conditioned construction of the landslide body.

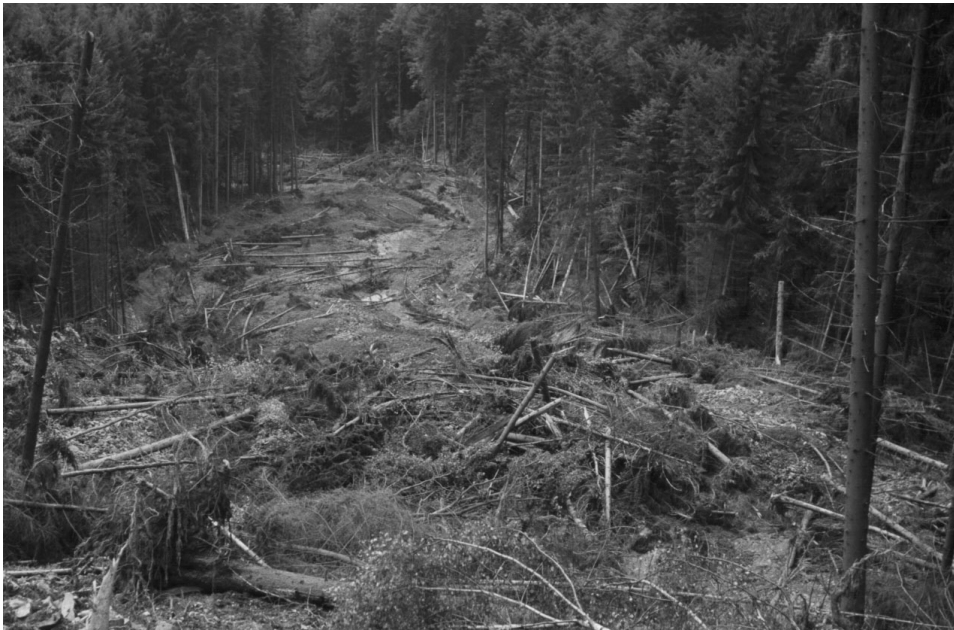
Photo 4: Accumulation part of the large earth flow in the woody area of Brodská locality near the Karolinka village. (Photo Oldřich Krejčí)

In the landslide locality of Brodská (Photo 4) near Nový Hrozenkov village, 15 km to E from Vsetín town, a landslide area with highly destructive effects in the landscape occurs in the left valley slope of the Malá Brodská brook (a right tributary of Vsetínská Bečva river) where a structurally conditioned earth flow (about 690 m in length and some 80 m in width – Rybář 1999). The slip blocked a forest road and destroyed a large grown-up forest. The impressive segregation area of the landslide is structurally geologically conditioned amounting to the height of 6–15 m. Flysch sediments started to move along the layer areas and fissure up to a distance of at least 100 m. The accumulation part of the landslide is about 100 m long and its height nearly 10 m. The lower part of the slip reached the brook bottom where it further proceeded along the

stream bed some 150 m. The landslide resulted in extensive damage to forest stands whose rescue is practically unrealistic from the viewpoint of area size and technical works (Kirchner, Krejčí 1998).
