Slope movements in Callejón de Huaylas, Peru

ABSTRACT

Slope movements in Callejón de Huaylas (the Santa River valley) are of different origin according to the variety of their causes. This paper is describing the area of Huascarán Mt. and Cañón del Pato. Rock and ice falls belong to the most well known, but also debris flows and slumps occurred in this area. The high dynamic of the relief in connection with seismic shaking and local heavy rains are the main triggering factors. The slope movements are also of different sizes from huge catastrophes which belong to the most serious in the western hemisphere to local ones which influence daily life in densely populated areas of Peru.

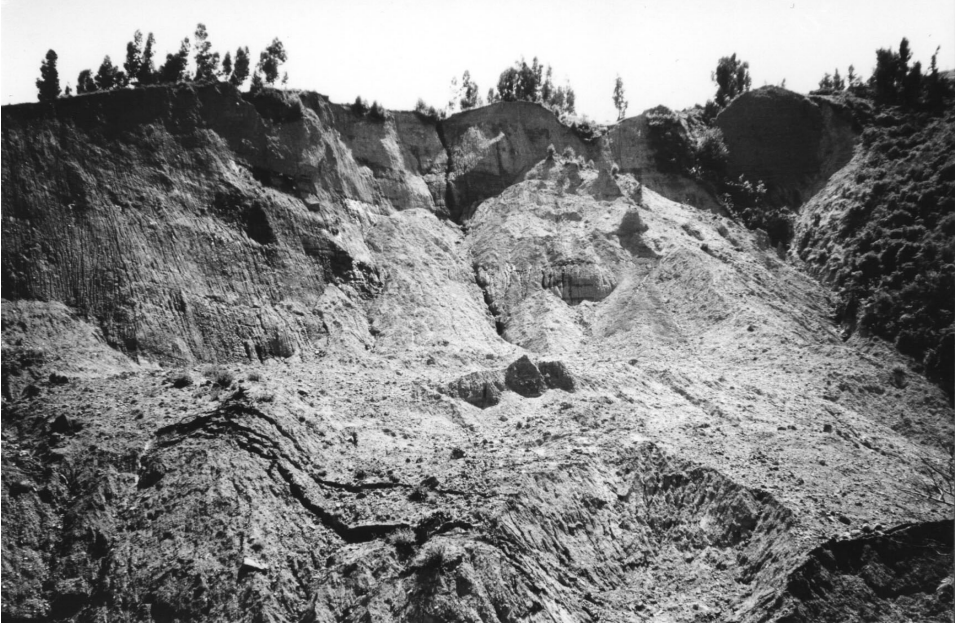
Photo 1: A blockslide in the right tributary of the Santa River (below the village of Monterrey. (Photo by V. Vilímek)

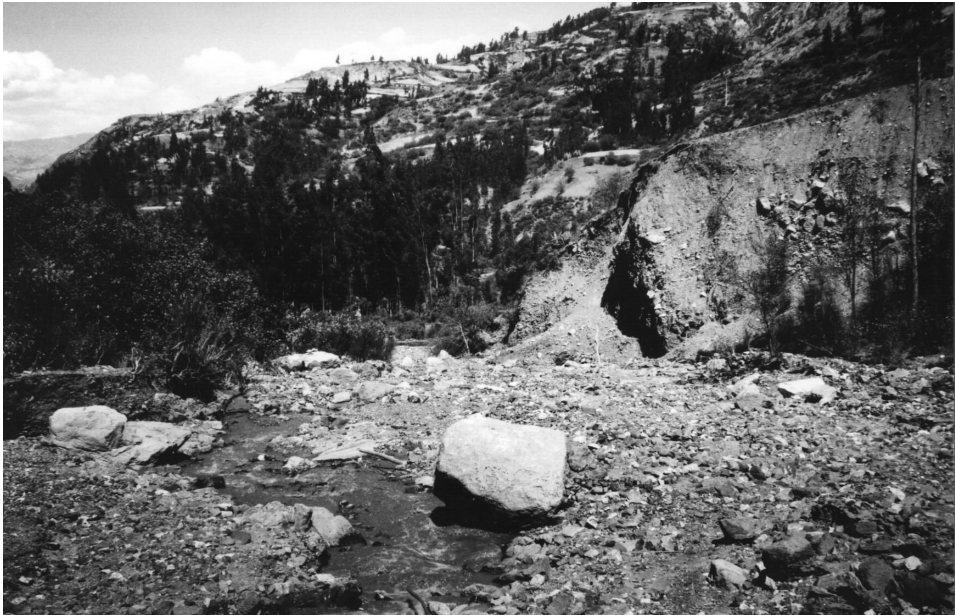
Photo 2. Transported material from the above mentioned blockslide (Photo 1) which changed the cross profile of the valley (close to the main road going through Callejón de Huaylas). (Photo by V. Vilímek)

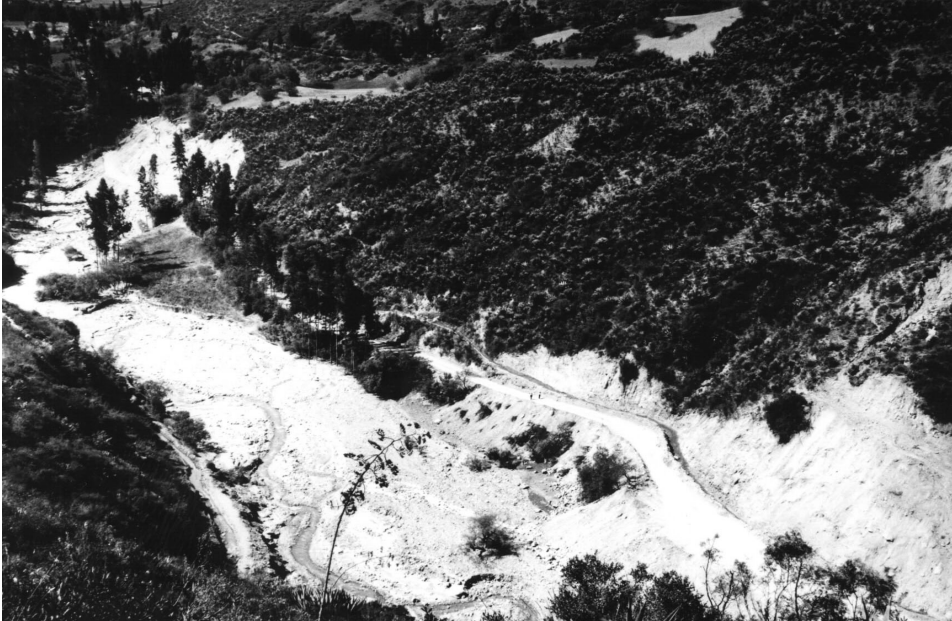
Photo 3: Non-consolidated material was transported by a debris flow from Cordillera Negra. Small slides from lateral slopes are well visible. (Photo by V. Vilímek)

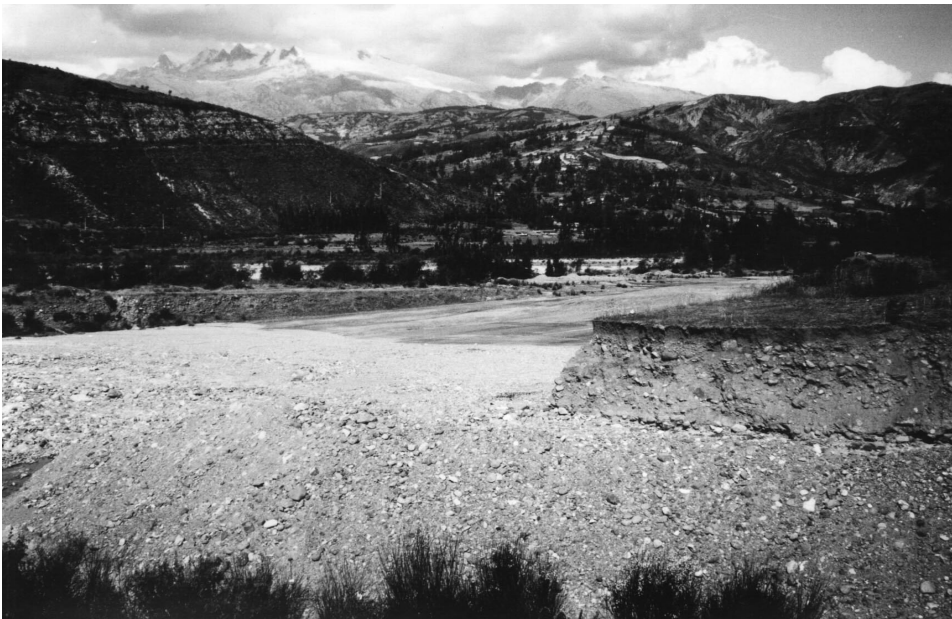
Photo 4: The airport by Marcará (close to Carhuaz) was blocked by a debris flow coming from Cordillera Negra. (Photo by V. Vilímek)

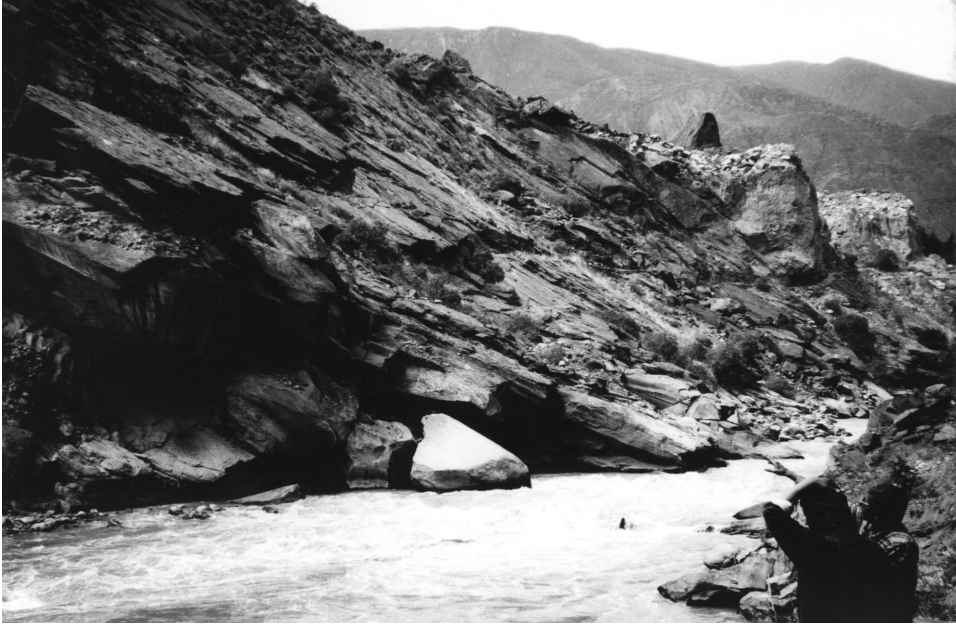
Photo 5: Cañón del Pato could be blocked by a rock slide especially during an earthquake. Detached slabs are creeping under gravity. (Photo by V. Vilimek)

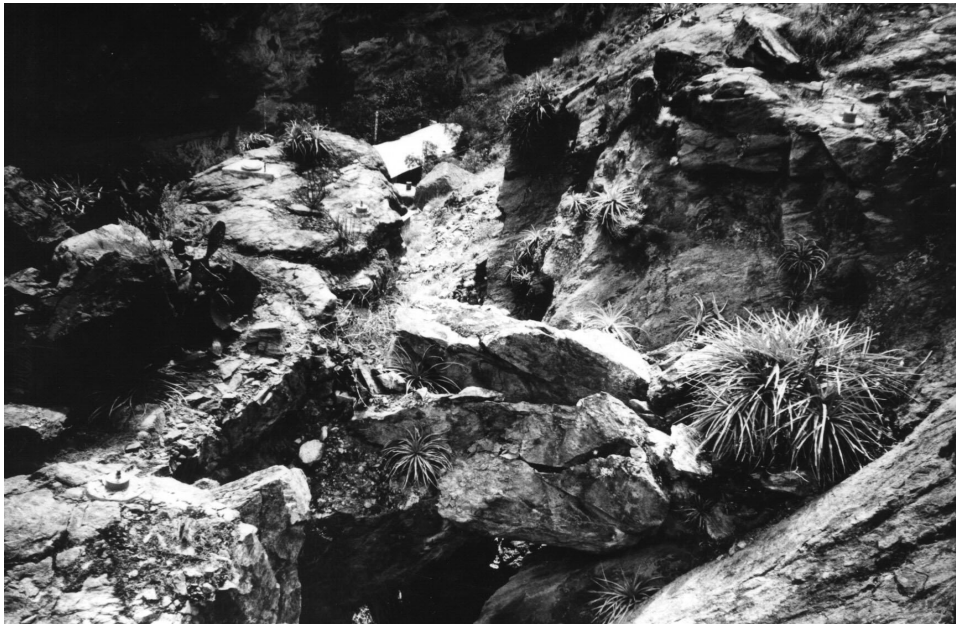
Photo 6: The upper part of the rockslide (Photo 5) is heavily disturbed with large open trenches between separate blocks. (Photo by V. Vilimek)

Apart from the described rocksliding, there are, in the upper zone, open trenches which comprise a considerable hazard during an earthquake. Any significant slope movement could totally block the Santa River and form a lake, which after sudden break would produce a flooding situation. The present equilibrium, determined only from visual observations, is only a temporary state.

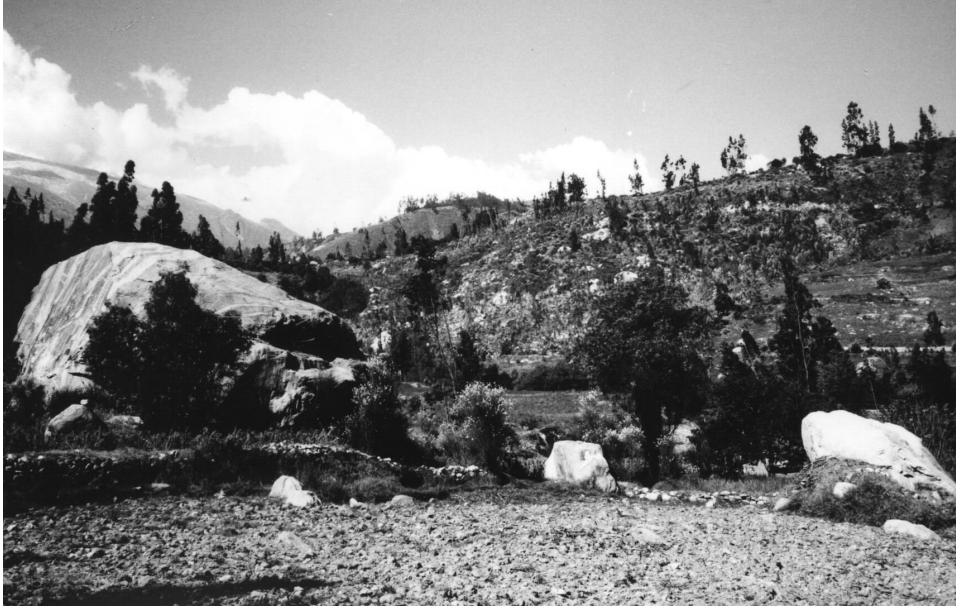
Photo 7: Large blocks of granodiorites are spread on the SW slope of Huascarán Mt., due to ice- and rockfalls. (Photo by V. Vilímek)

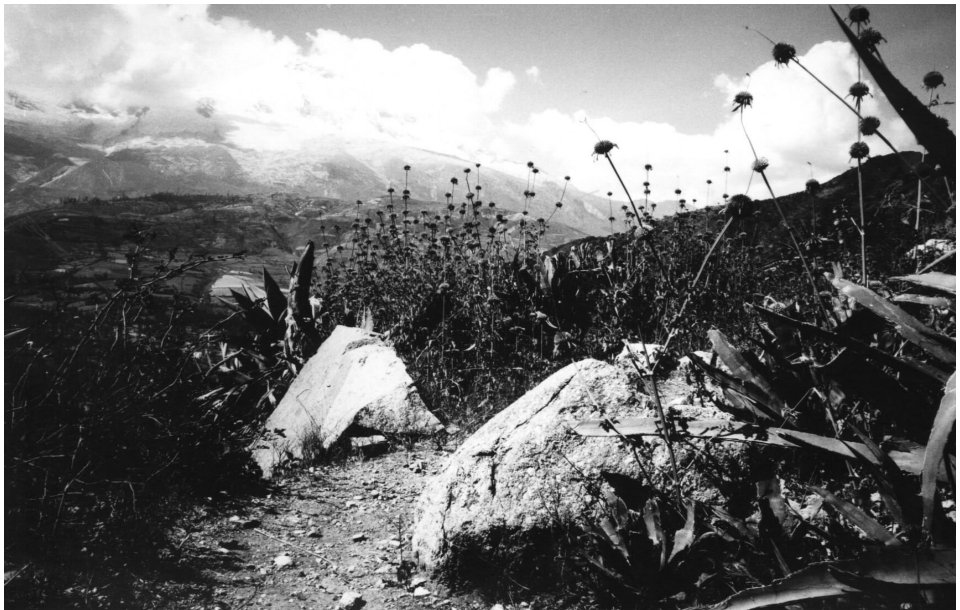
Photo 8: Some blocks of granodiorites reached the lower part of the Cordillera Negra slope, which consists of volcanic material in this area, after the rockslide from Huascarán Mt. It means that these blocks went across the Santa River up into the opposite slope of Huascarán. (Photo by V. Vilímek)

According to Plafker – Ericksen (1978) debris runs up to a vertical distance of 123 m, 40 m higher than the 1970 deposit. They describe blocks several meters across which contrast with the much smaller size of the rocks that make up the 1970 deposit at this location. According to our field investigation the limit is at a level of 2, 540 m a.s.l., close to Matacoto village. It means 150 m above the river water level.

Two boulders (30 x 50 cm) were found in a small, shallow stream channel under approximately 20 cm of local slope debris and pure soil. About 3 m down stream was another block found, partly rounded. This could mean that boulders might have been partly transported after deposition from an upper locality. Also the above mentioned fact that only larger blocks from a pre-Columbian avalanche were found, compared with that of 1970, could suggest that the extent was in fact larger and small stones could not have survived on the steep slope up to now. The rather coherent cover of pre-Columbian deposits is developed at a level of 2, 525 m a.s.l. The blocks measure up to 1,5 m in diameter. In the river bed it is possible to see huge blocks from the pre-Columbian deposits. They were exhumed by the river action. In contrary, the large blocks described by Plafker – Ericksen (1978) at the slope of the Huascarán Mt. and similar ones registered by authors on the opposite site of the 1970 event are at the surface, only partly buried in slope deposits due to their weight. We know that this huge avalanche occurred somehow before the Spaniards arrived and due to the 20 cm thick cover of local debris and soil it was not „just before“.
