## **Ecomorphological evaluation of the stream habitat quality and its application on the model area of Rakovnický Stream Basin**

The ecomorphological evaluation of stream habitat quality is one of the new, complex evaluation methods that monitors the level of anthropogenic influence on water ecosystems. The article presents the method "Ecomorphological evaluation of the habitat quality of small and middles sized watercourses in hilly country areas", and its application in the model area of Rakovnický Stream Basin.

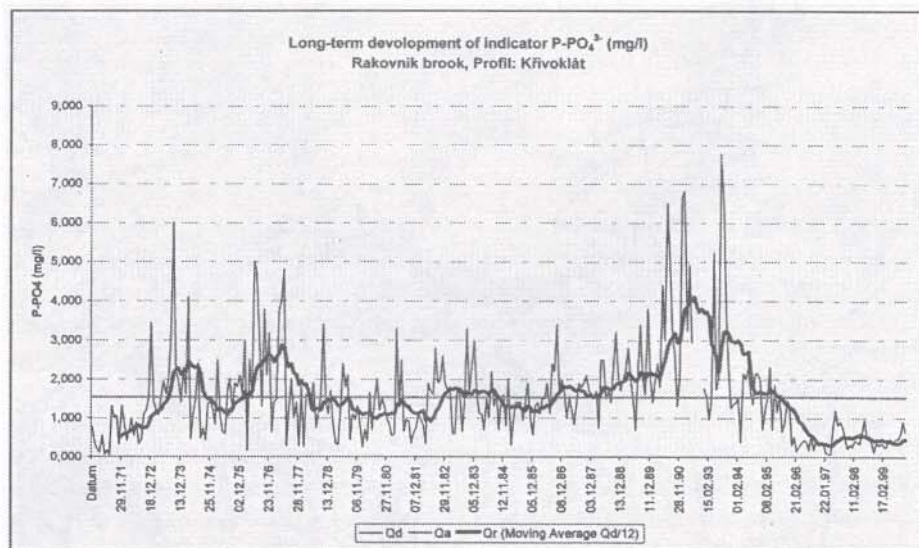
Fig. 3 Long-term development of concentration P-PO<sub>4</sub><sup>3-</sup>

The lower course of the Rakovnický Stream can also be deemed as very polluted, as the parameters BOD<sub>5</sub>, COD<sub>Cr</sub> indicated the 3<sup>rd</sup> quality class, N-NH<sub>4</sub> the 4<sup>th</sup> class and N-NO<sub>3</sub>, P-PO<sub>4</sub> the 5<sup>th</sup> class. Here the source of pollution is still the city of Rakovník and communities lying in the valley of the Rakovnický Stream. This pollution is dissatisfactory, since the lower course runs into the Protected Landscape Area (PLA) Křivoklátsko.

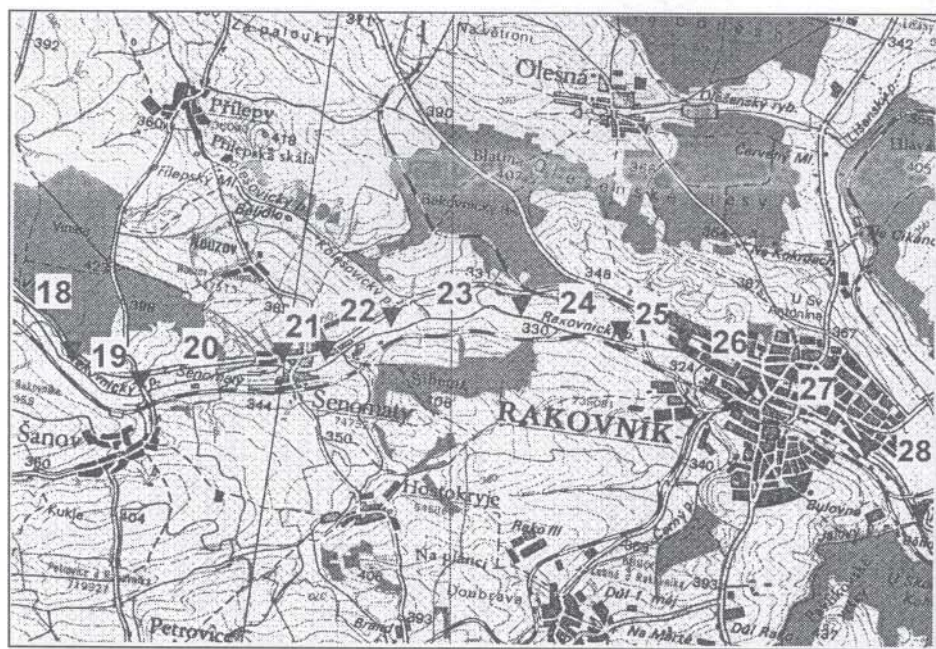
Fig. 4 Delimitation of ecomorphological segments

Ecomorphological evaluation of the habitat of the Rakovnický Stream was performed along its entire length from the source to the mouth, i.e. 48.4 km. Terrain mapping took place in three basic zones, i.e. the watercourse bed, riparian belt and the flood plain. A total of 46 sections of equal length were determined. Localization of individual sections is indicated on Fig 4, 5. In the **zone** of the streambed of the watercourse, the parameters of *morphology meandering, longitudinal profile, cross section profile, streambed structures and stream bank structures* were evaluated. According to the results gained it's possible to divide the watercourse into several areas. Already the point of the upper stream (sections 1,2,3) is anthropogenically influenced to a great degree (4<sup>th</sup> quality class) from the aspect of the aforementioned parameters (Fig 5). This is because hydromelioration and alterations of the streambed occurred. Here are mostly straightened, artificially reinforced sections with quarry stone or concrete prefabricate with medium diversified stream flow and a low diversity of substrate. On the upper stream in the territory of the Jesenicko Nature Park there appear mainly slightly anthropogenically-influenced structures. Sections 4–6 under the Krtský fishponds are classified as natural and near-natural. The streambed here is found in its original course, it is natural with unfortified, irregular cross-section profile, with middle variability of depths and widths.

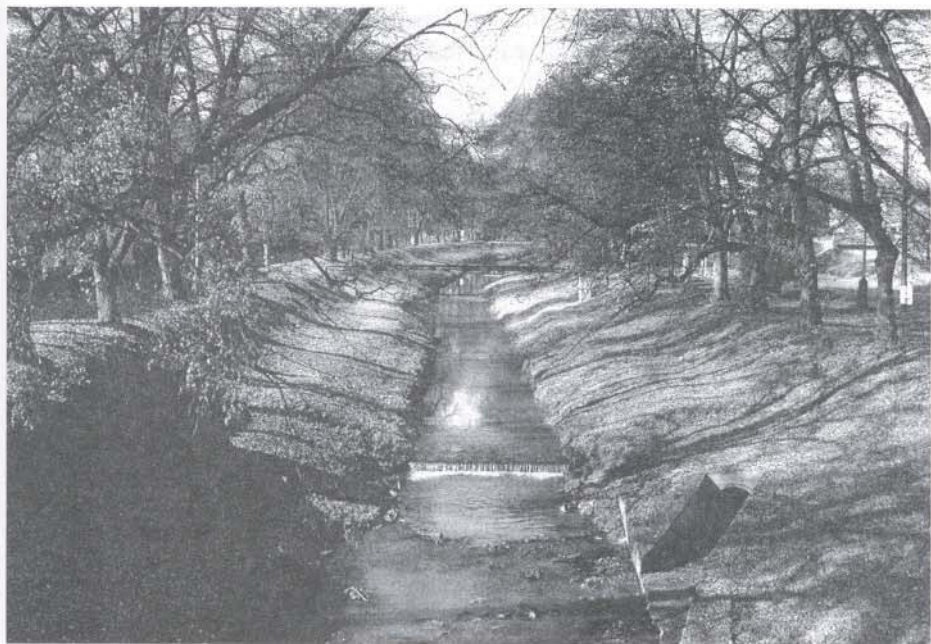
*Photo 1* Section (no. 6) river training of the Rakovnický Stream

The overall ecomorphological condition of the Rakovnický Stream, evaluated on the basis of an analysis of the three aforementioned zones can be characterized in summary as dissatisfactory. Strongly anthropogenically influenced sections make up 23.5 % of the total watercourse length. This state is extremely dissatisfactory starting at the source (sections 1, 2, 3, i.e. 45.7–48.4 km.), where the streambed is straightened and reinforced, vegetative belts are not sufficiently developed here and intensive agricultural use of lands along the watercourse has occurred. Also sections 14–16 along the middle course between the communities of Oráčov and Pšovky are heavily anthropogenically influenced areas. This is the same for section 23 and sections 26–29 found within the territory of the city of Rakovník (Photo 1).

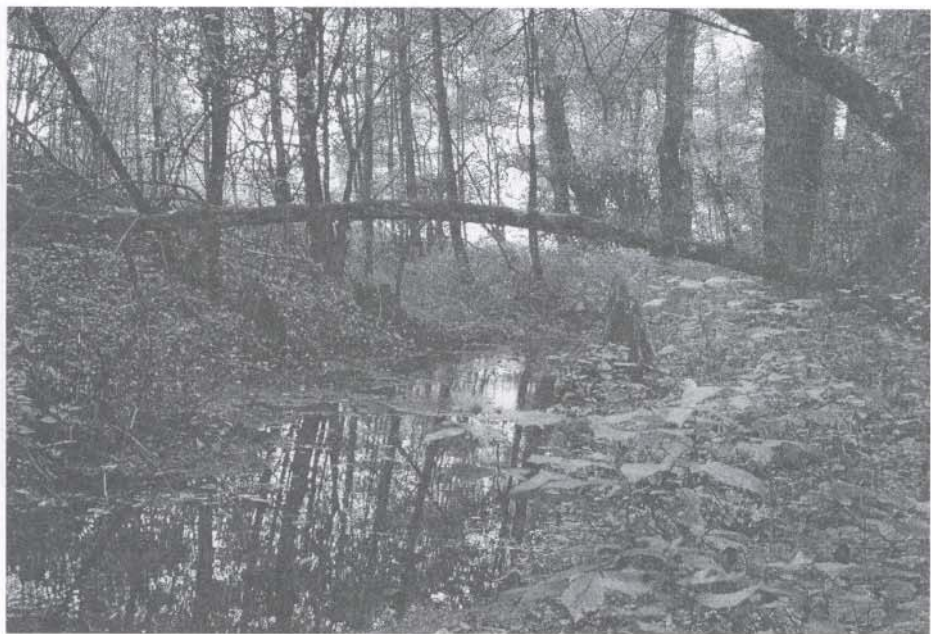
*Photo 2* Natural section (no. 5) of the Rakovnický Stream

Natural sections make up only 7.7% of the total stream length. As natural were indicated sections 4 and 5 in the upper flow, and sections 37 and 44 on the lower course (Photo 2), which should be the subject of special protection. Ecohydrologically important are also near natural sections, which are slightly antropogenically influenced.
