Geomorphological Consequences of the 2002 Flood in the Otava River Drainage Basin

Geomorphological consequences of the 2002 flood were mapped in the Otava river drainage basin. Field mapping was focused on relief changes in river beds and floodplains and on flood geomorphological indications in adjacent slopes. Geomorphological consequences of the flood according to anthropogenic impacts into floodplains were assessed.

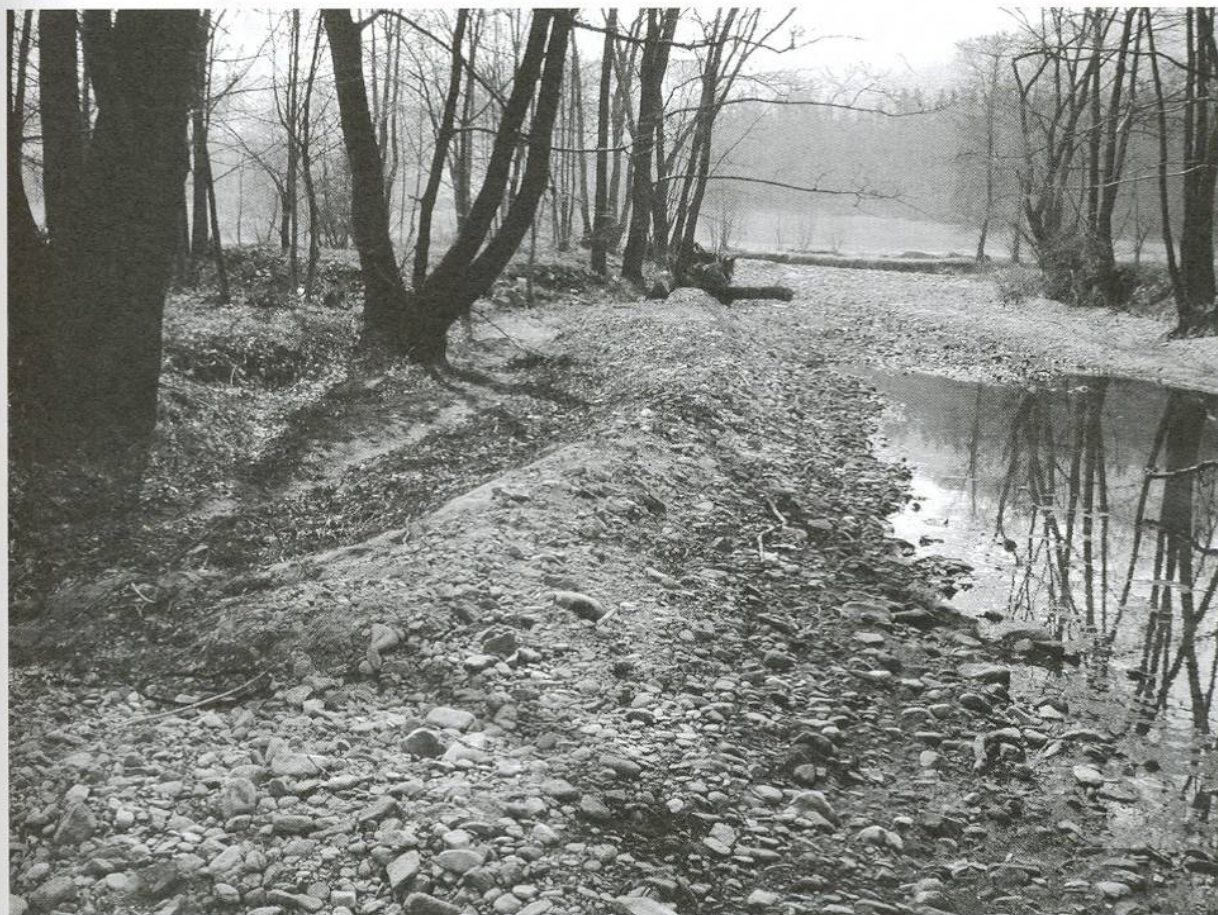
Photo 1 Abandoned river bed of the Volyňka river (near Malenice). Shifted river bed of the Volyňka river was formed in consequence of the cracking of its right bank, which was weakened by mining of river sands (Photo by Z. Engel, 2003)

Shifted and abandoned river beds. Such linear geomorphological forms were created in areas where watercourse acted with the greatest erosive force, i.e. areas of increased flow velocities conditioned often by anthropological interventions. Circumstances allowing for river bed shifting were also created due to river beds silting or banks weakening (Photo 1). Such forms were abundant in the Blanice river upstream areas, the Volyňka river upstream and midstream and, in the Otava river upstream. The length of new river beds varies from 200 m to 600 m and arose either by accumulation in the river bed and consequent splitting of watercourse or by destruction of the bank in river bends.

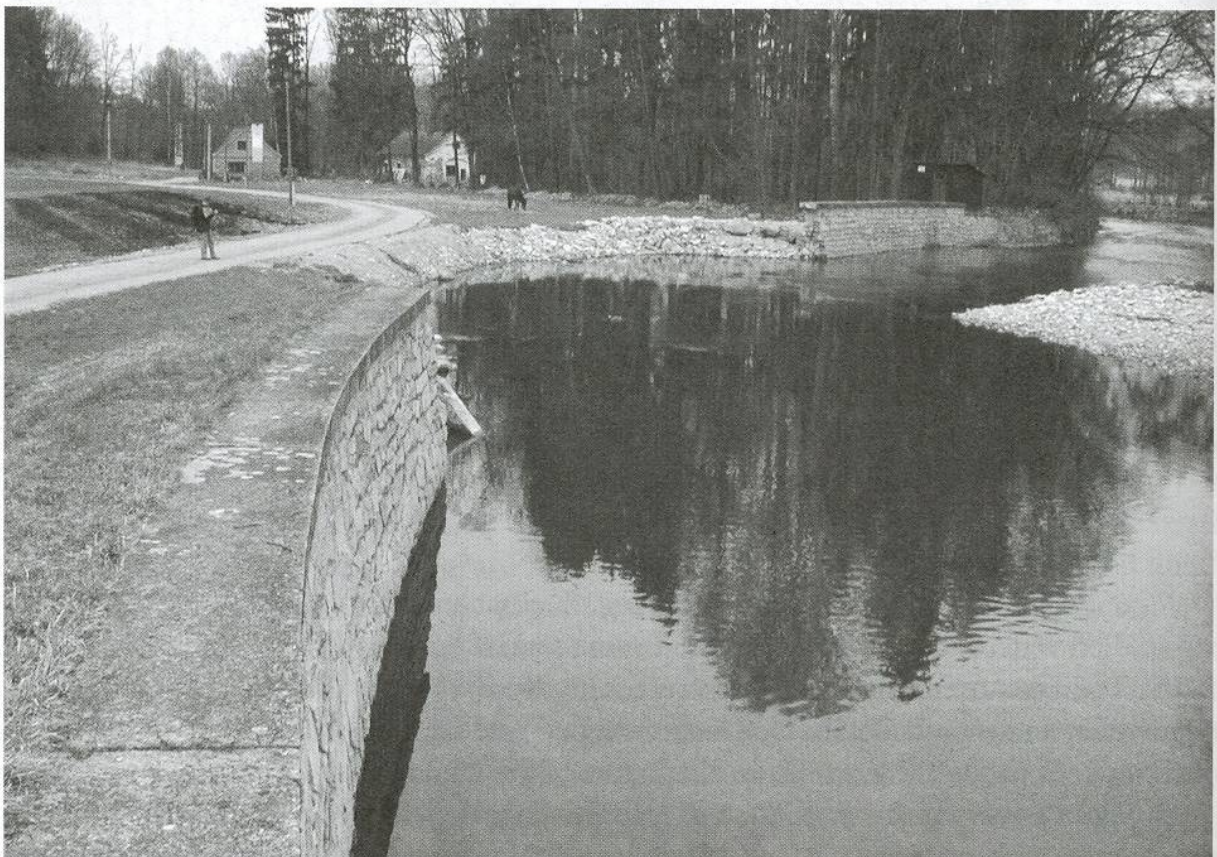
Photo 2 Broken flood-control levee in the Volyňka river near Volyně. During the flooding the main stream headed straight to houses (Photo by Z. Engel, 2003)

above and under the town of Volyně (Photo 2). Besides, there were many minor water outbreaks around weirs of width varying from several meters to tens of meters. Bursting of a pond levee on the Brložský potok stream led to a domino effect of levee bursting on ponds located further along the stream due to an anthropogenically accelerated flood wave. Levee bursting was also common on the Volyňka river midstream and on the Bavorovský potok stream. In terms of potential risks, mounds and levees pose a considerable threat derived from their potential destruction and acceleration of erosion processes.

width – 4 m), and in Sušice (height – 3 m). However, levees proved to be effective only in Radošovice, while others were broken (Volyně) or overflowed (Čkyně, Přední Zborovice, and Strakonice).

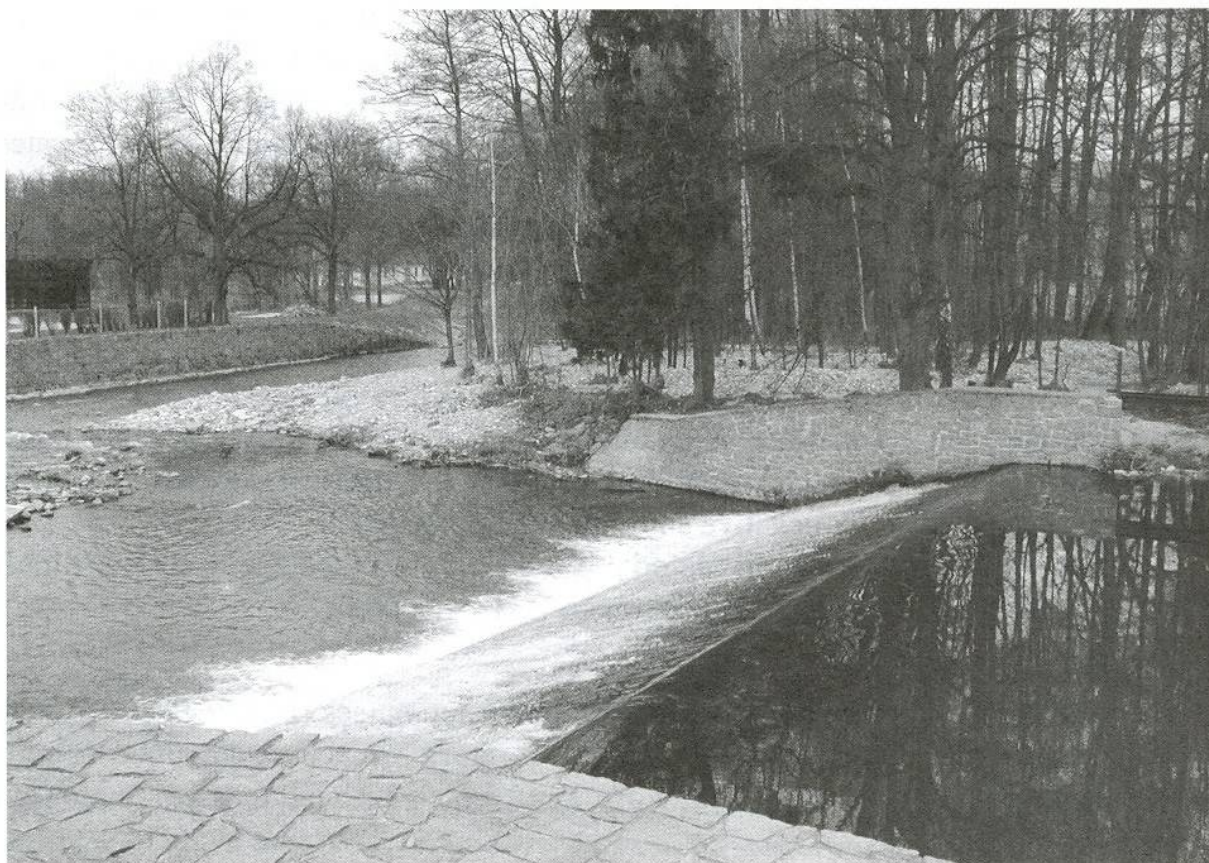
Photo 3 Surroundings of weirs are dangerous and more prone to overspill due to water flow. This location of weir near Volyně is good example of total ignorance of natural principle of water circulation in case high flow rate of water. This weir is situated in front of orthogonal bight of river. Gravel-stony accumulations on the bank are a proof of the lapse of the purpose of this weir and the threat of neighbourhood localities by deflected main stream of the Volyňka river (Photo by M. Křížek, 2003)

The negative geomorphological consequences are caused also by weirs, inappropriately located in bends of river channels, i.e. areas where direction of river beds changes. Significant erosional and accumulative processes resulting in catastrophic consequences were always concentrated around such weirs, e.g. Volyně weir (Photo 3).

In the periods of abnormally high water levels, weirs become centres of intensive erosive and accumulative fluvial processes. Building new weirs, smaller ones should be given preference over high weirs. Their locations should be carefully selected with respect to surrounding area condition and mainly the characteristics of watercourses and floodplains (weirs shouldn't be built in bights or meanders and the nearest surrounding areas).

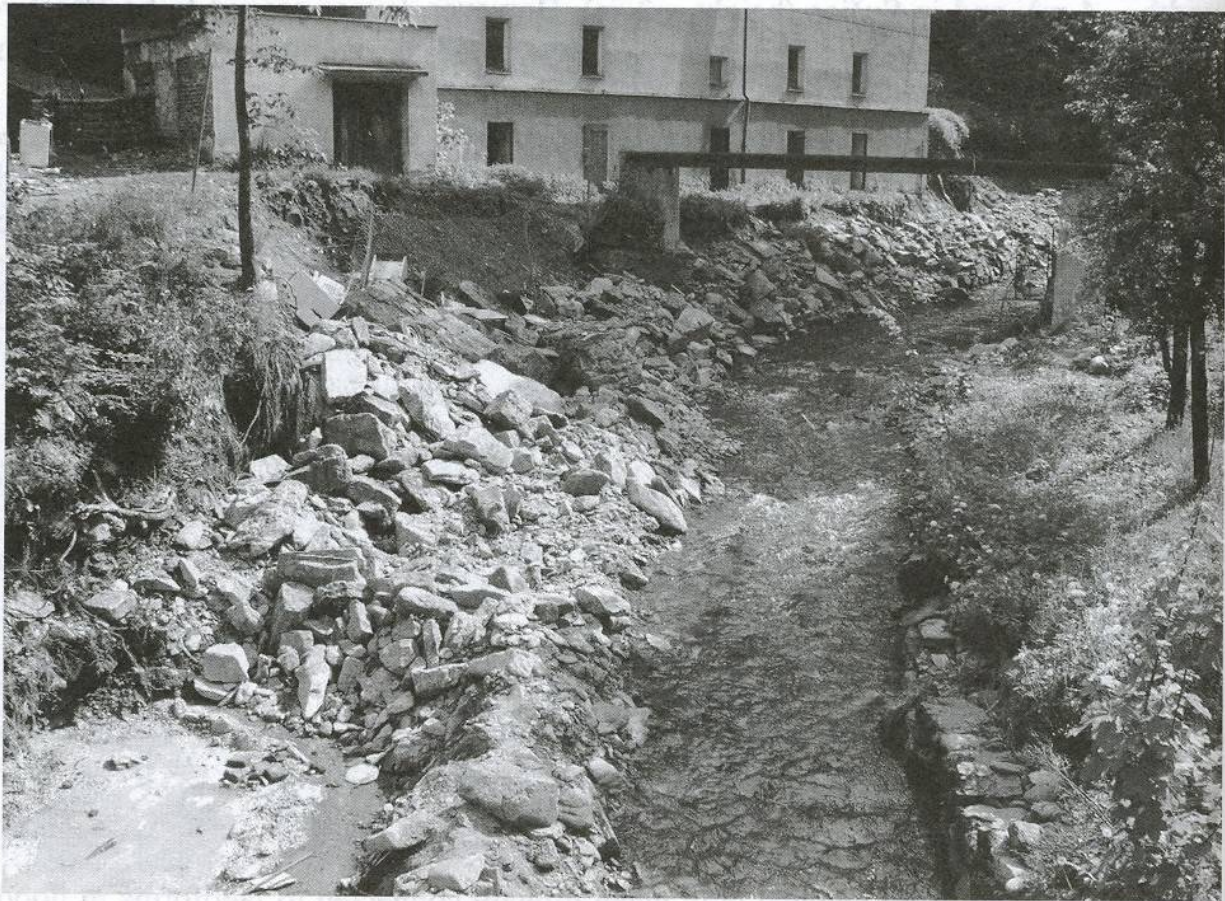
Photo 4 Damaged flood-control levees and anthropogenic reinforced bank in the Volyňka river in Vimperk. It is a result of anthropogenic restriction of the river bed capacity (Photo by M. Křížek, 2003)
