## **Interpretation of causes of a flash flood in the Olešenský potok brook drainage area**

### **Abstract**

The main cause of the so-called flash flood that occurred in the Olešenský potok Brook drainage area on June 10 and 11, 2004, was above all an abnormal rainfall. Human interventions into the natural environment had only a negligible impact on the flood magnitude and thus on the consequent material damages. Substantial flood damages were mainly due to inappropriate development in the floodplain and to the consequent narrowing of the flood discharge profile as well as to the existence of low capacity bridges in the built-up reach of the floodplain. In the upper and middle part of the basin, where the valley has still maintained its natural character, abnormal erosion and accumulation locally occurred, but this is a part of natural development of a valley.

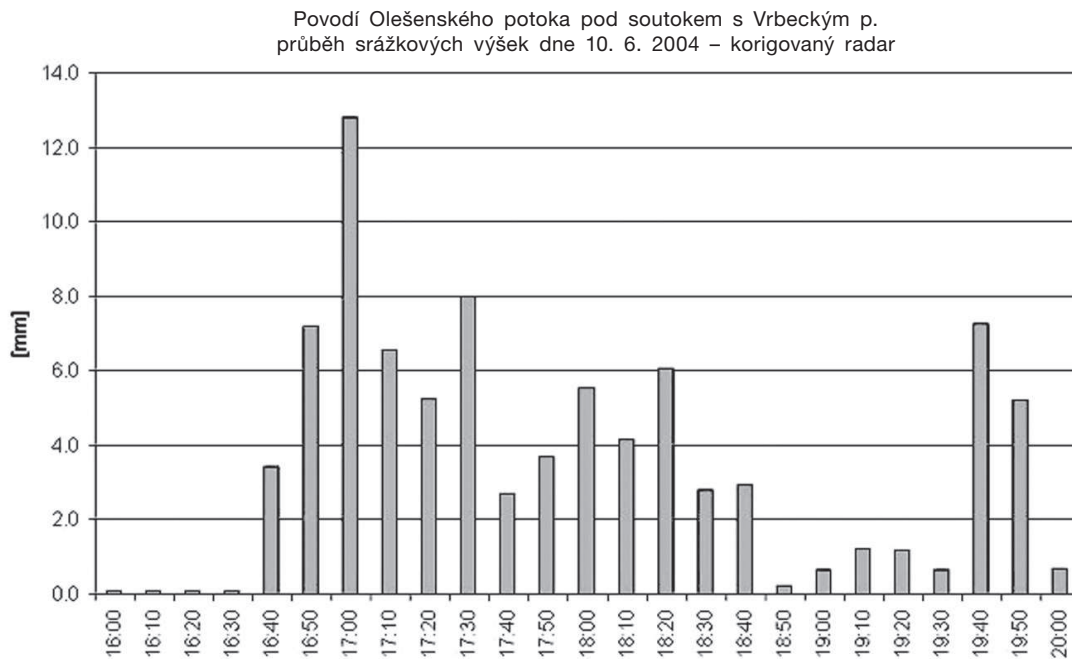
The highest average ten-minute intensities in the basin were recorded for the time period between 16:30 and 18:30 CEST with the peak between 16:50 and 17:00 (Fig. 2). During the mentioned two hours, more than 60 mm of precipitation fell over the whole catchment, which is probably more than the 100-year recurrence period. Intensities were still higher in the upper course, where 100-year recurrence period was largely exceeded, and that also with regard to 24-hour rainfall sums.

Fig. 2. Probable hyetograph of ten-minute intensities of rainfall in the Olešenský potok Brook drainage area downstream the confluence with the Vrbecký potok Brook.

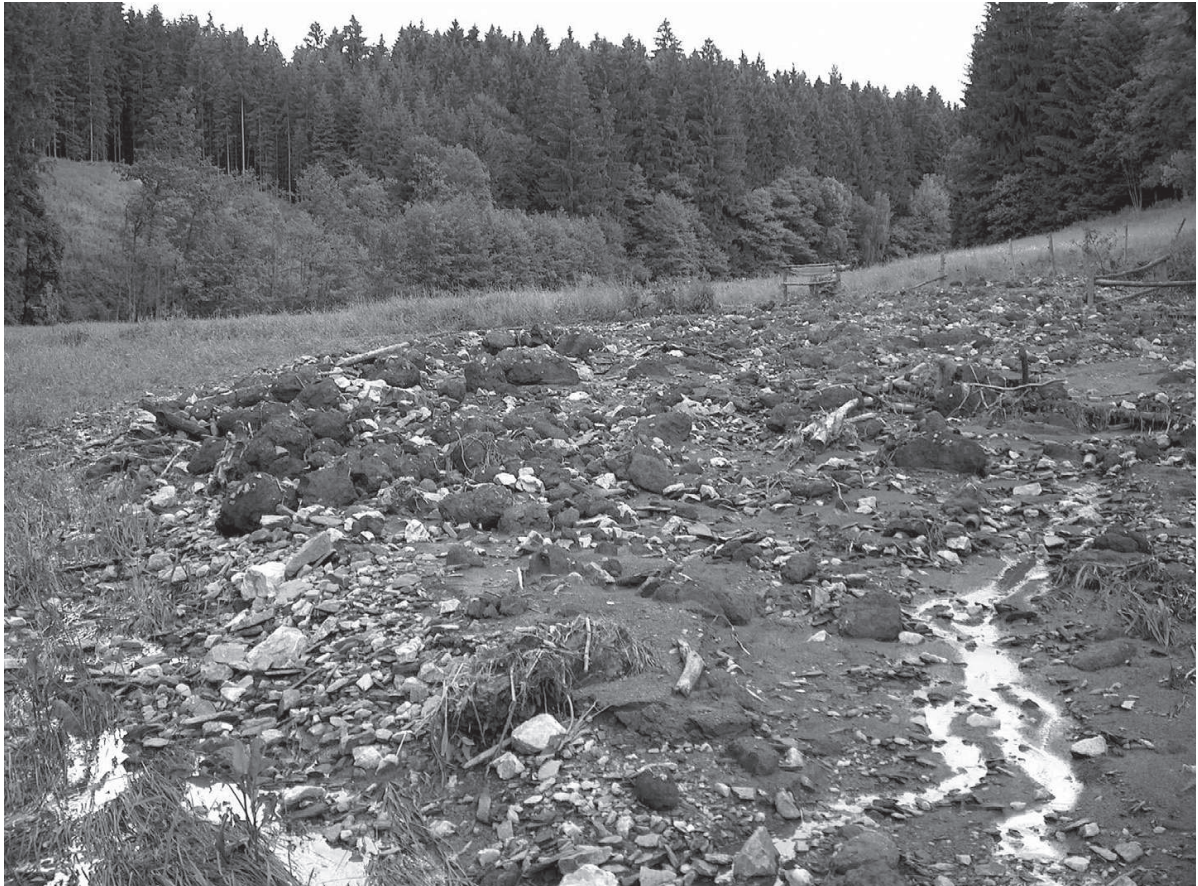
*Photo 1* During the flood dejection cones were locally formed by the material washed away from lateral ravines containing clay clods.

was found that in collecting areas of these recently re-deepened ravines there are light to medium soils from the granularity viewpoint, i.e. relatively well permeable soils. Neither this factor was decisive in formation of this flood situation. The only factors that could have locally speeded up the runoff from the catchment are the clayey positions taking place in the middle course of the Olešenský potok Brook. They are a part of the weathered mantle (Photo 1) and they are impermeable.

rate of erosion (Photo 2 and 3), which caused again an enormous sedimentation in the floodplain (Photos 1 and 4). This was true for instance for the area eastwards from Hlohov (on a left-bank tributary of the Olešenský potok Brook). These sediments were deposited in the nearest places of flow velocity reduction, i.e. in places where erosion gullies join the floodplain.

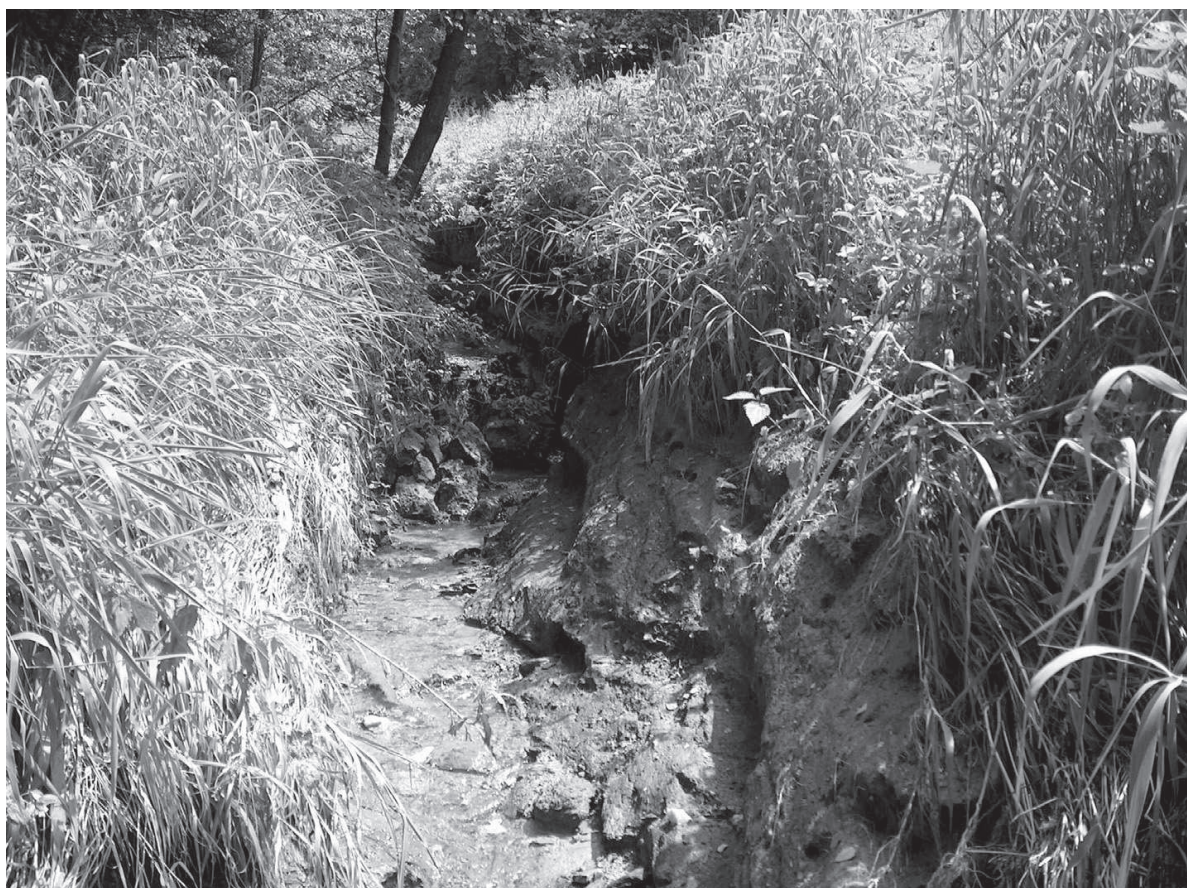
*Photo 2* Intensive erosion at the margin of the floodplain (up to the depth of 1 m).

In several places, deep erosion furrows (up to 1 m) were found in a relatively small collecting area (north-westwards from Zdeslavice), partly covered by meadows or forests (Photo 2). There are no fields. In this part of the Olešenský potok Brook catchment, flood progressed quite differently along its left-bank tributaries. Abnormally deep erosional furrows formed during the flood alternated with older ravines without any more pronounced manifestations of erosion. In a short reach of a comparable inclination of slopes, there were large differences in the intensity of erosion. It can be explained by local changes in rainfall intensity within the area affected by thunderstorms. In the floodplain, sharp-edged material from slope deluvium was often found, which proves again a strong deep erosion both in soil cover and in upper parts of the weathered mantle where stone debris are partly rounded. Only deeper parts of weathering mantle contain sharp-edged debris.

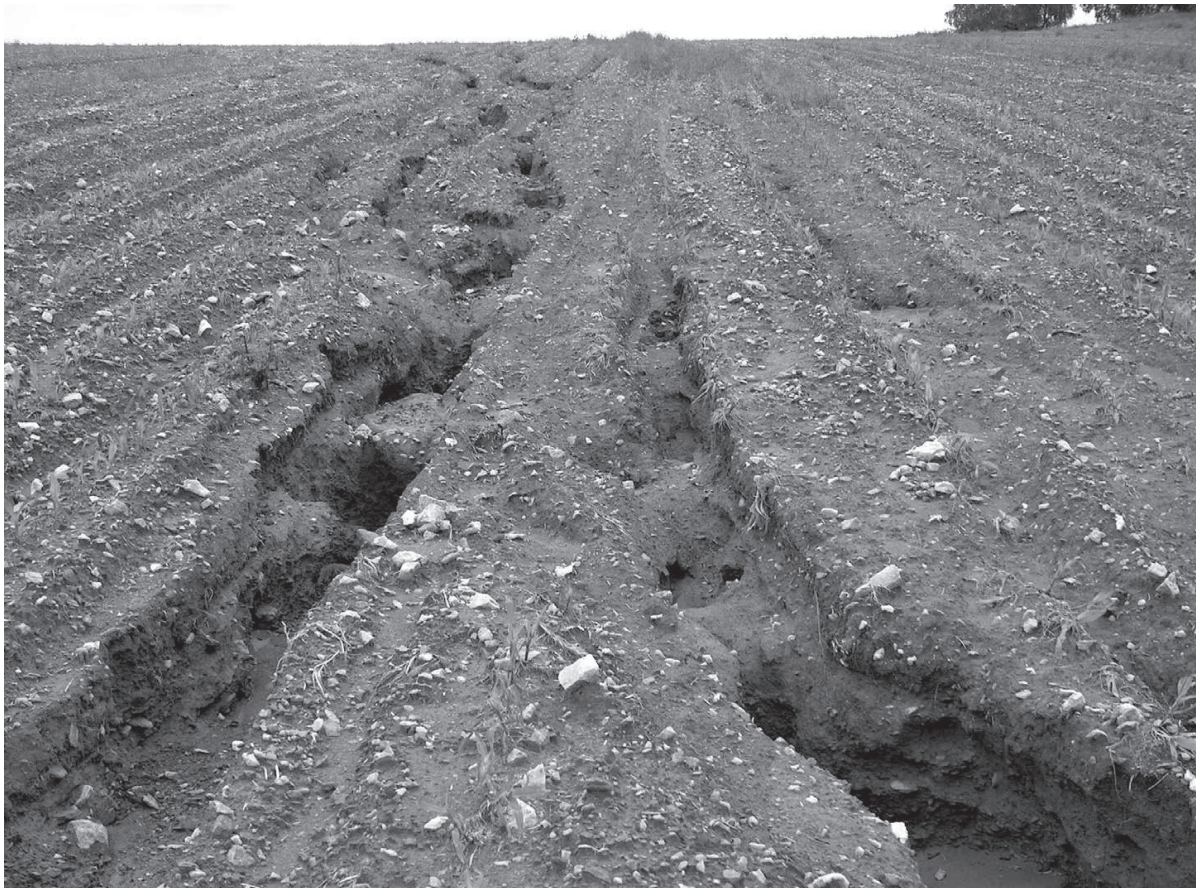
*Photo 3* Erosion of the maize fields (along the road Tunochody-Hlohov villages).

Because slopes with maize fields are easily affected by soil erosion during intensive rainfall, this vegetation cover is entirely unsuitable. Not only because of flood prevention, but because of protection of the soil itself. Similar problems with erosion in maize fields were recorded for instance by field research in the Haraska watershed (Šefrna and Vilímek 2003). It is nevertheless necessary to realize that the vegetation impact is more important during smaller floods than during larger ones (Janeček 1997).

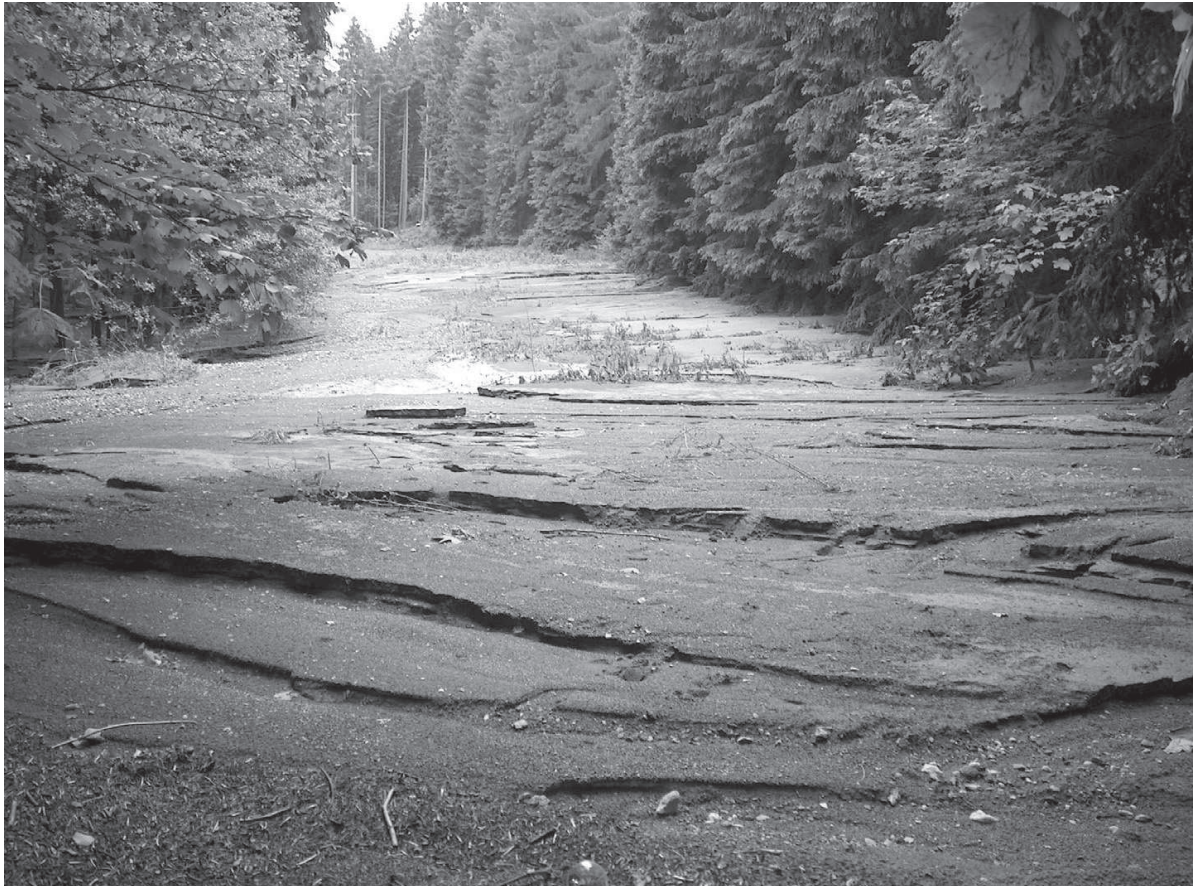
*Photo 4* Abnormally intensive accumulation of soil and weathered material runoff from maize fields. Sediments have completely covered the floodplain.
