Flood Frequency and Seasonality in the Sázava River Catchment Based on Historical Cases

LIBOR ELLEDER

CHMI Prague, Department of Hydrological Forecasting

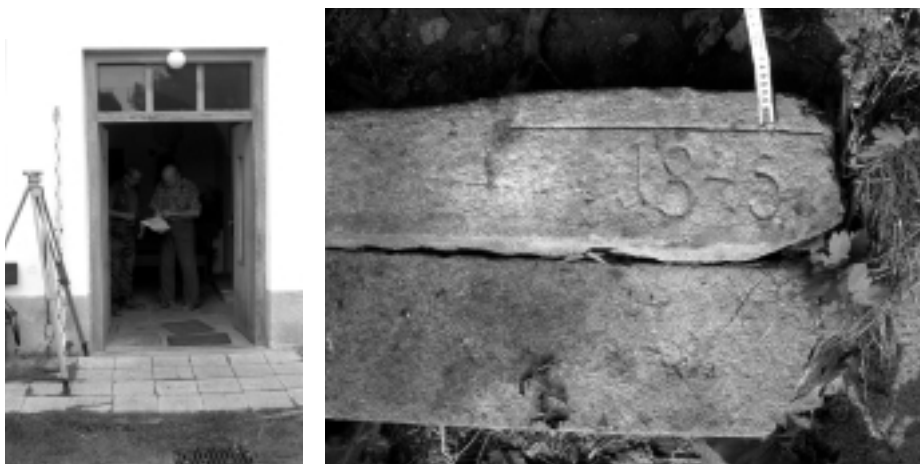
Figure 1: Buda mill near Zruč n. S.: The floor bar with the engraved 1845 mark (right) was removed from the entrance door (left) during renovation. Photo by: Author

newer 1845 and 1862 flood marks exist any more (still measured in the 1930s). There was an extraordinary case of finding a relocated 1845 flood mark within the Buda mill premises near Zruč nad Sázavou (Fig. 1) thanks to kind help by the mill's owner (the mark was found on a hill of eliminated stone construction units). Compared to the 1930s, fewer than 25% of flood marks or heights evidenced at that time have been preserved (Tbl. 1). Relatively favourable state is only in Nespeky and Chlístov. Near the Žampach ferry, an 1888 mark has been found, and, similarly, there is an 1878 mark (or on the mill no. 33 in Kamenný Přívoz).

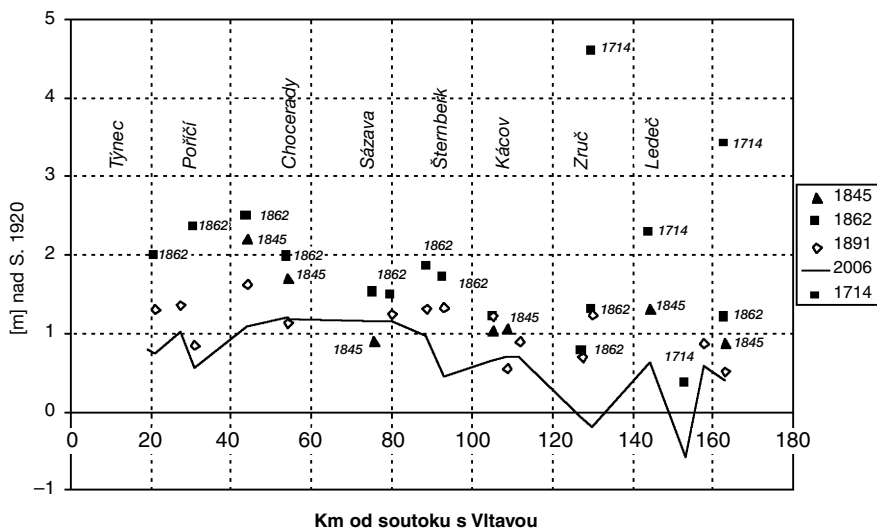
Figure 2: 1714, 1845, 1862, 1891 and 2006 spates according to measured levels (related to the July 1926 flood levels)

The so far reached field investigation results are schematically shown in Figure 2, comparing the more important 1845, 1862 and 1891 floods with the last 2006 event. The June 1926 flood, which is available in most profiles, was used as comparison level. It is evident that the 1862 flood was not exceeded by the 2006 flood along the whole 160 km long Sázava River section, what mainly applies to the 1891 (with the exception of the Buda mill) and 1845 (with the exception of Č. Šternberk) floods. On Sázava headstream, the evidenced 2006 levels were lower than the June 1926 ones in two cases.

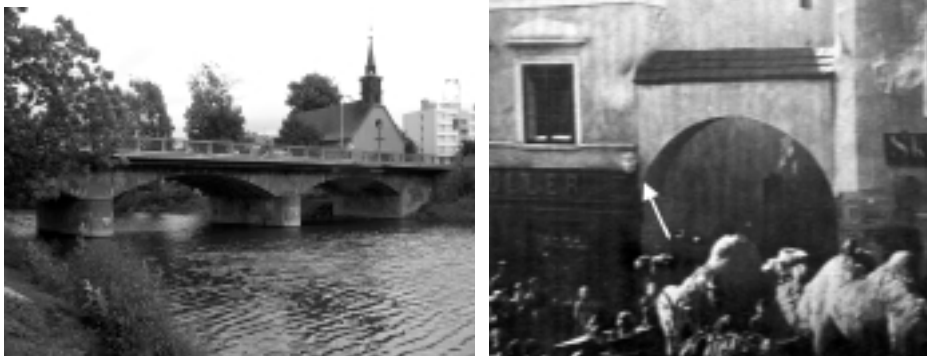
Figure 4: On the left: Havlíčkův Brod; on the left St. Catherine's Church flooded up to ca. 3 m in 1714; on the right 97 Dolní Street; sidewalk height under the "Bearded Man" sculpture corresponds to the flood reach. Photo by: Author and Havlíčkův Brod Museum's archive.

Based on a measurement in Havlíčkův Brod, the flood extent corresponds to the distance of today's Riegrova Street and 97 Dolní Street (see also Tbl. 5). The unusually fast water level rise was accompanied by devastation of the river bank town part where, rather coincidentally, only St. Catherine's Church (Fig. 4) remained saved.

Havlíčkův Brod	
House 97 Dolní Street	Water level reached the doorstep. Until 1894 the place had been identified by the so called Bearded Man of Havlíčkův Brod (Fig. 43). The sculpture was placed ca. 3 m higher, at the butment of the street vaulted arch (simultaneously, water probably reached to house no. 153). According to the measurement, the level reached ca. 413 m a.s.l., i.e. roughly 200 to 240 cm higher than the 1862 flood.
Former Rosmarkt	Up to house no. 77 (former Trčkova St.) – whole neighborhood torn down while building a new condominium neighborhood. Original state cannot be measured.
St. Catherine's Church	A/ Position under the ceiling (ca. 10 cm); B/ Position ca. 3 m above the floor (up to half of the altar; paintings were not damaged), approximately corresponds with the level stated for house no. 97; C/ minimum height 90 cm (mud accumulation thickness).
Okrouhlice	
Chateau wall	Foot of chateau wall is at a height of 400.37 m a.s.l. (allegedly, water spilled up to the chateau wall) $HW_{2006} = 399.76$ m ASL, $HW_{1714} = >$ at least 60 cm higher than 2006.
