GEOMORPHOLOGY AND NATURAL HAZARDS OF THE SELECTED GLACIAL VALLEYS, CORDILLERA BLANCA, PERU

JAN KLIMEŠ

ABSTRACT

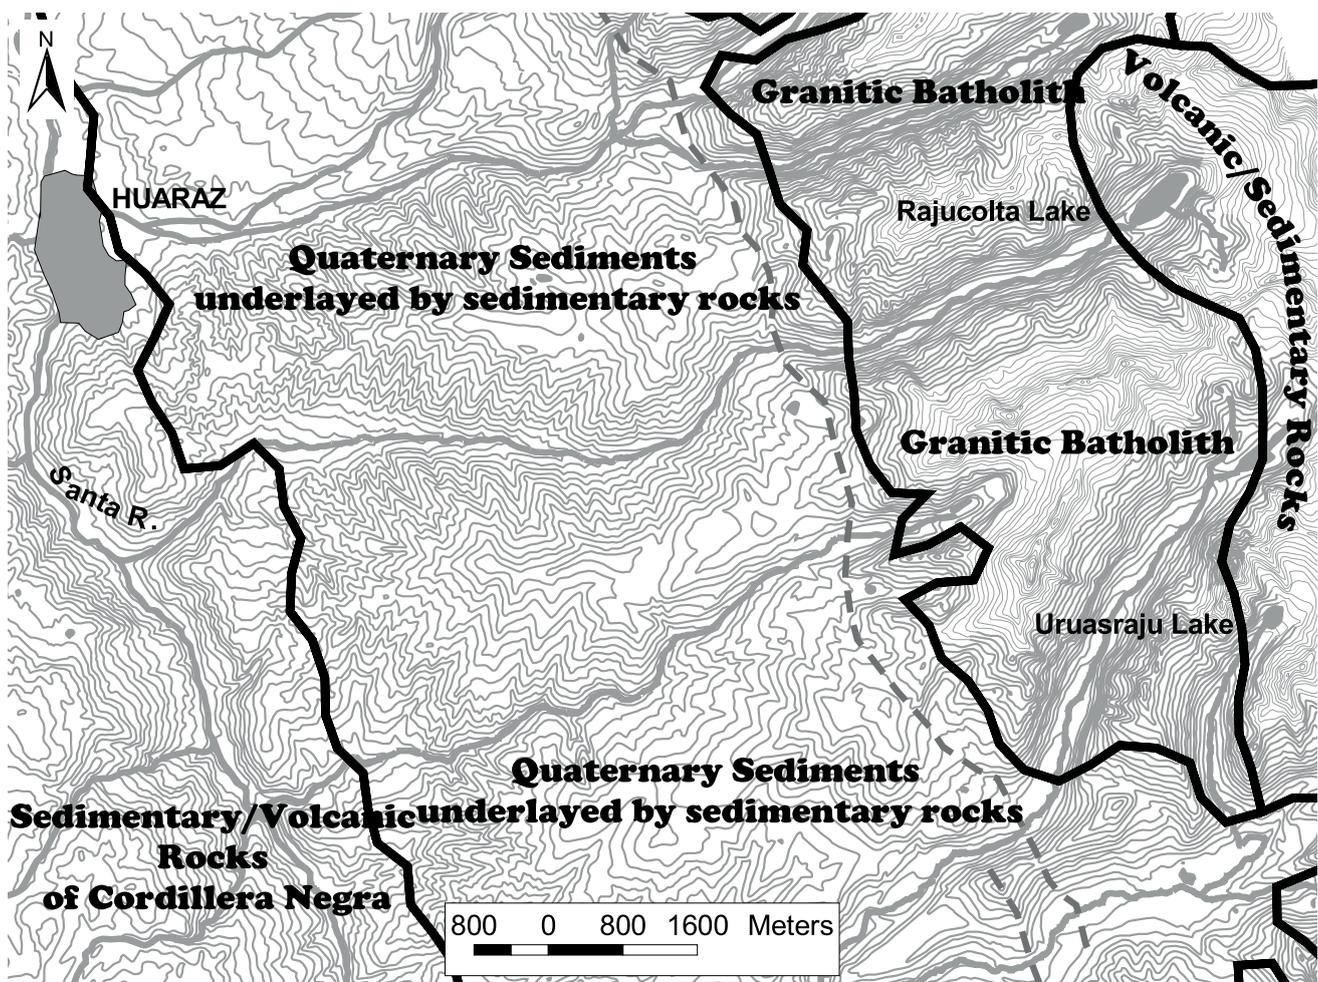
Fig. 2 Geology of the study area. Limits of the geological units are in black solid line, gray dashed line shows Cordillera Blanca normal fault

Major part of the Cordillera Blanca Mt. constitutes of the batholith with total length of 200 km and width between 12 and 15 km. It is predominantly made of coarse grained granodiorite and tonality rocks (Figure 2) which are strongly foliated. In certain locations of the batholith, intrusive rocks gradually change to amphibolites. Dikes and sills of quartz-porphyry occur frequently in many locations of the batholith which is in contrast to the scarce occurrence of the basic rocks dikes. The age of the batholith is estimated shortly after Paleogene volcanism or in the Mio-Pliocene Era with K/Ar age calculated 16 ± 0.4 M.A. (Wilson et al. 1995).
