Assessment of Flood Course and Consequences

VÍT VILÍMEK, JAKUB LANGHAMMER

Charles University in Prague, Faculty of Science
Department of Physical Geography and Geocology

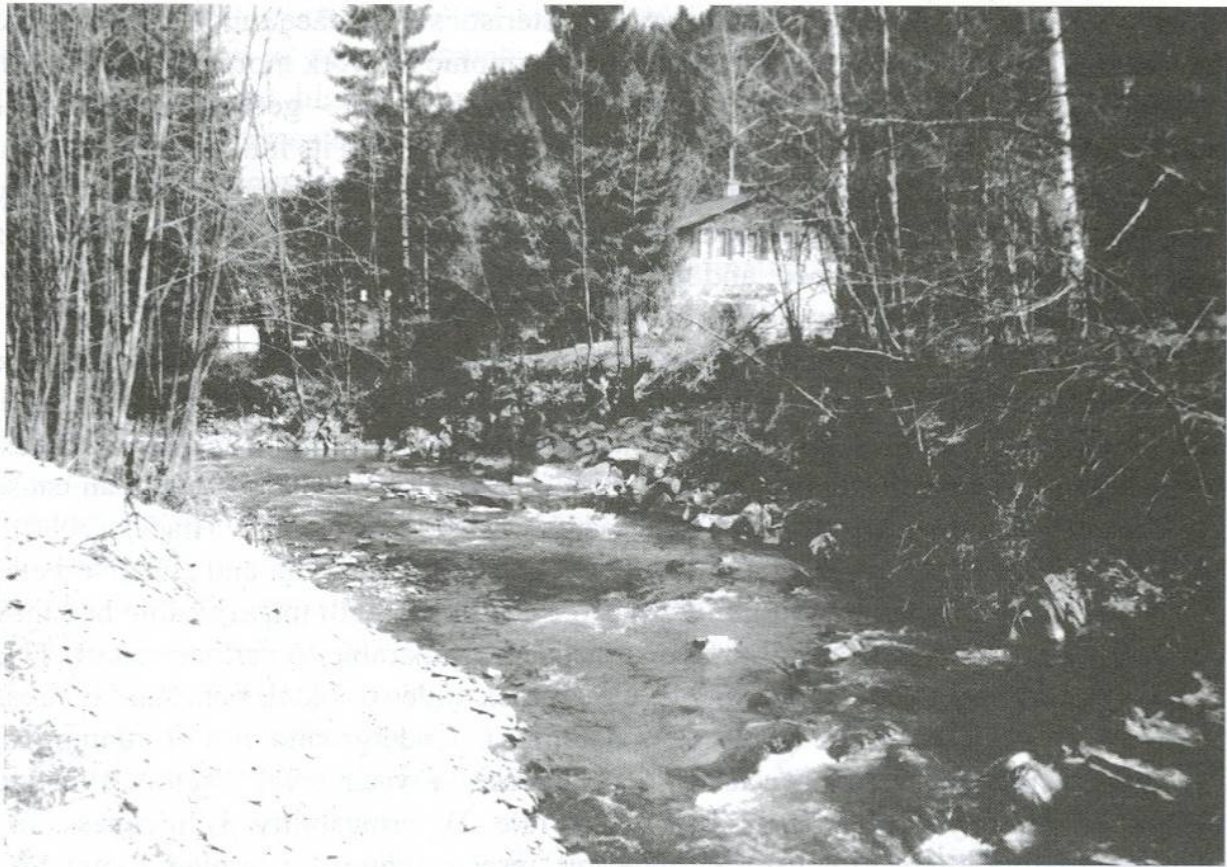
Photo 1 Lateral erosion in middle part of the Rožnovská Bečva river (Photo V. Vilímek)

- Lateral erosion is usually active on midstream or downstream watercourses (to specify impact on flood plains, links to landslides, and occurrence patterns), (Photo 1).

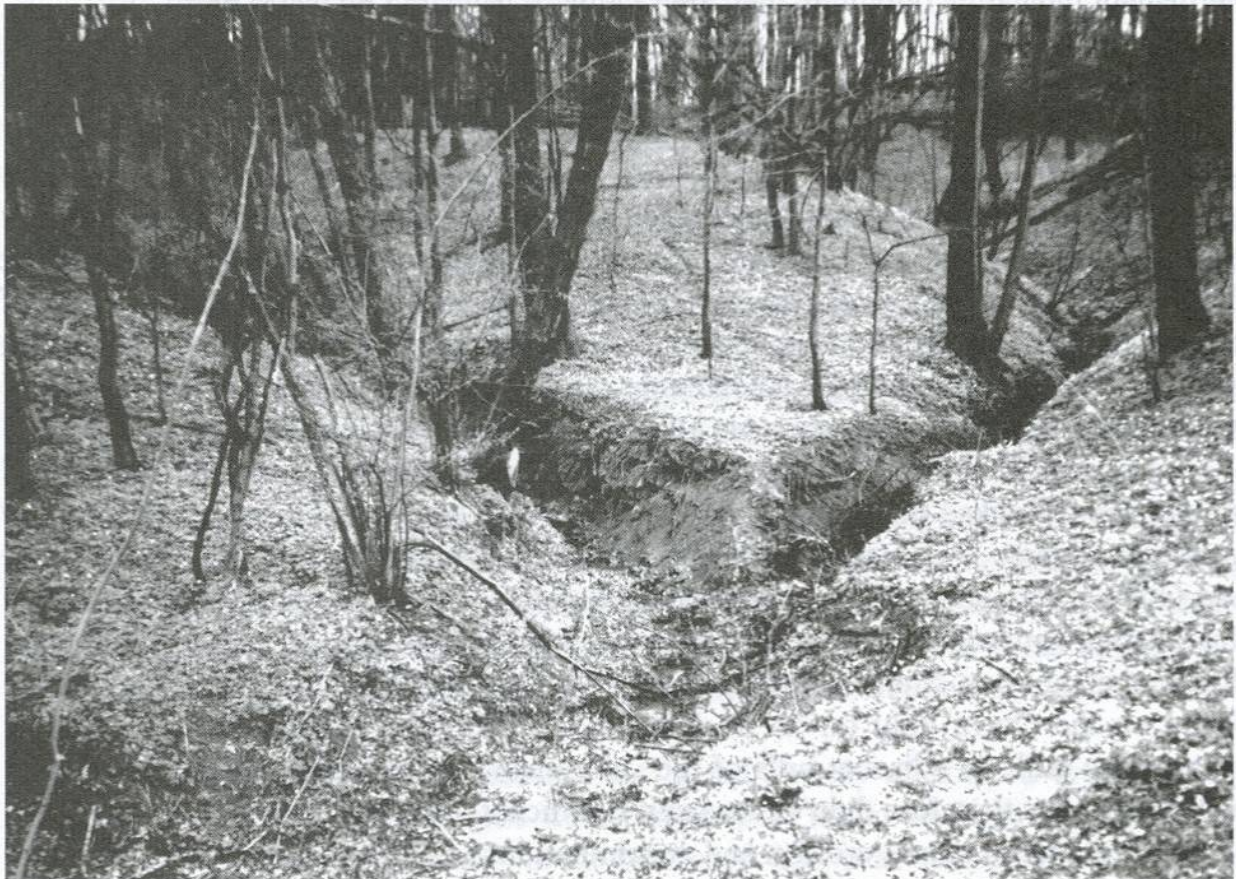
Photo 2 Bed erosion at the tributary of Vsetínská Bečva river. The incision was realised in the soil cover and weathered rocks (Photo V. Vilímek)

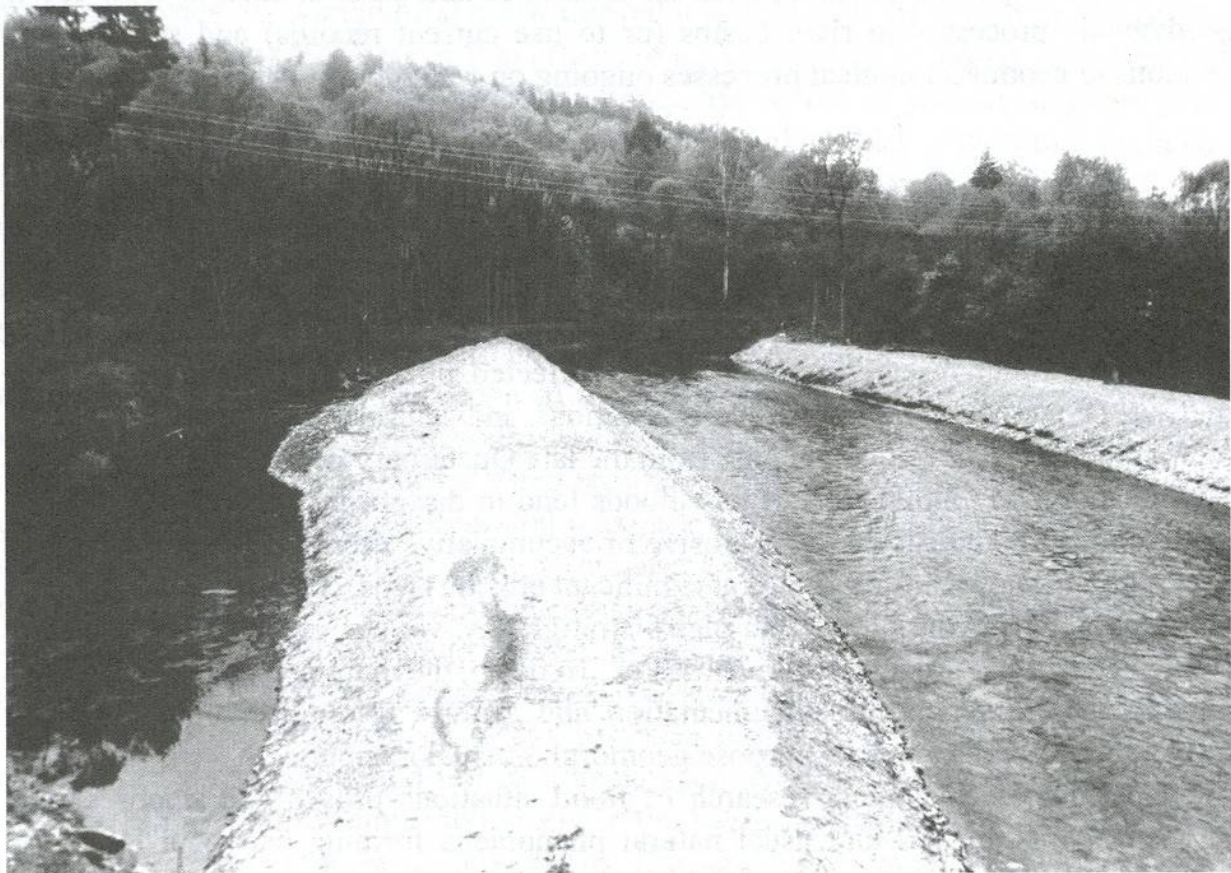
Photo 3. An example of wrong localised levees by Nové Heřminovy (Photo V. Vilímek)
